**NEW HAVEN
PUBLIC SCHOOLS
LONG-RANGE
FACILITIES
PLANNING STUDY**

Final 12-04-23

SECTION 1: DISTRICT VISION & STUDY PURPOSE

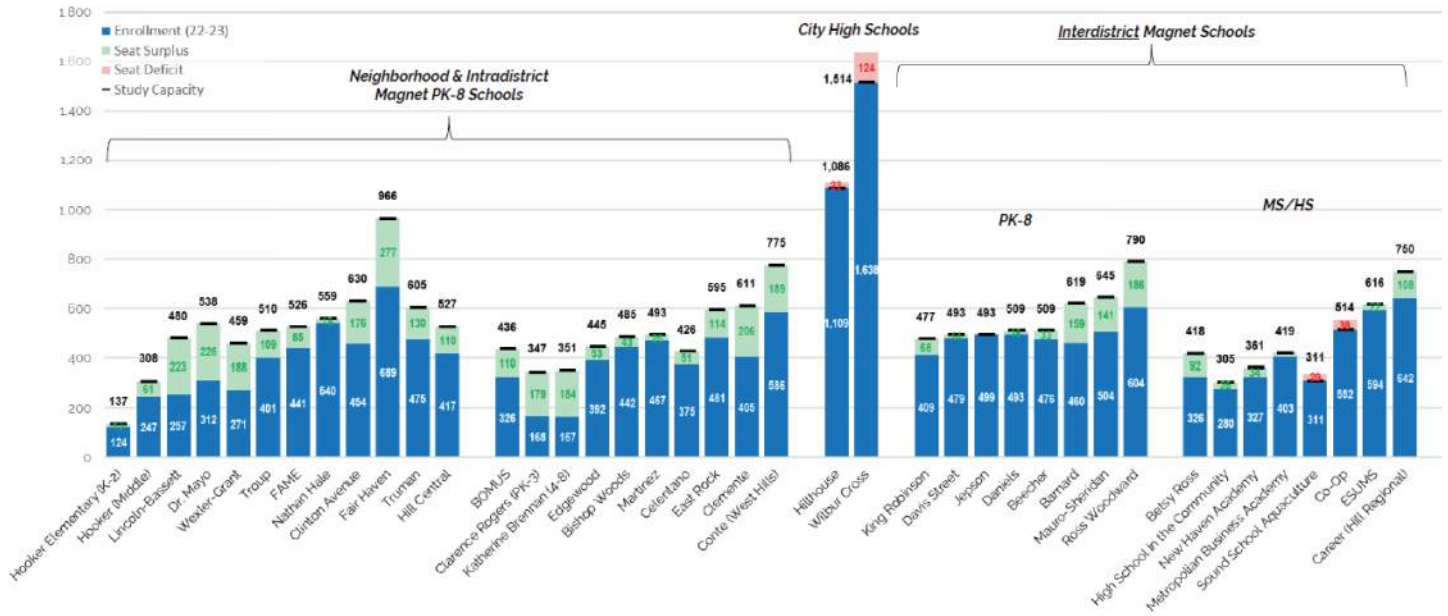
Figure 4.2: Comparison of 2022/23 Enrollment and Study Capacity, by School

The greatest share of surplus seats are at the PK-8 level, particularly in neighborhood and intra-district magnet schools as shown in Figure 4.2. Overall high school utilization is approaching 100%, however, trends vary by building. Hillhouse and Wilbur Cross are currently over their Study Capacity while there is some available seats in the inter district magnet high schools. However, due to the need to maintain at least 25% non-resident students in those facilities and the declining share of non-resident students at several high schools, these available seats cannot currently be filled by New Haven resident students. In order to address overcrowding at Hillhouse and Wilbur Cross, NHPS will need to maximize the use of space in its inter district magnet high schools. Strategies best leverage space at the high school level are found in Section 7.

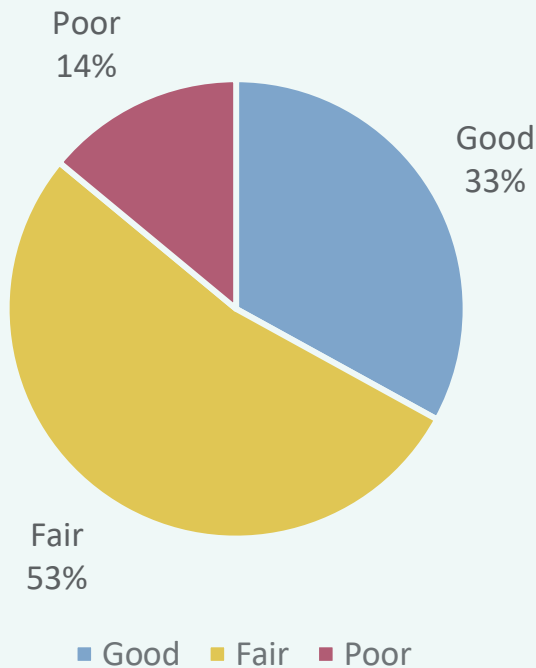
School Site Conditions

The overall site condition of each school varied and fell into one of three categories: Good, Fair, or Poor. A site in good condition has a 6- to 10-year life cycle before major repairs of the site features are needed. A site in fair condition has a 3- to 5-year life cycle before major repairs of the site features are needed. A site in poor condition has a 1- to 2-year life cycle before major repairs of the site features are needed. The breakdown of the overall school site conditions are as follows:

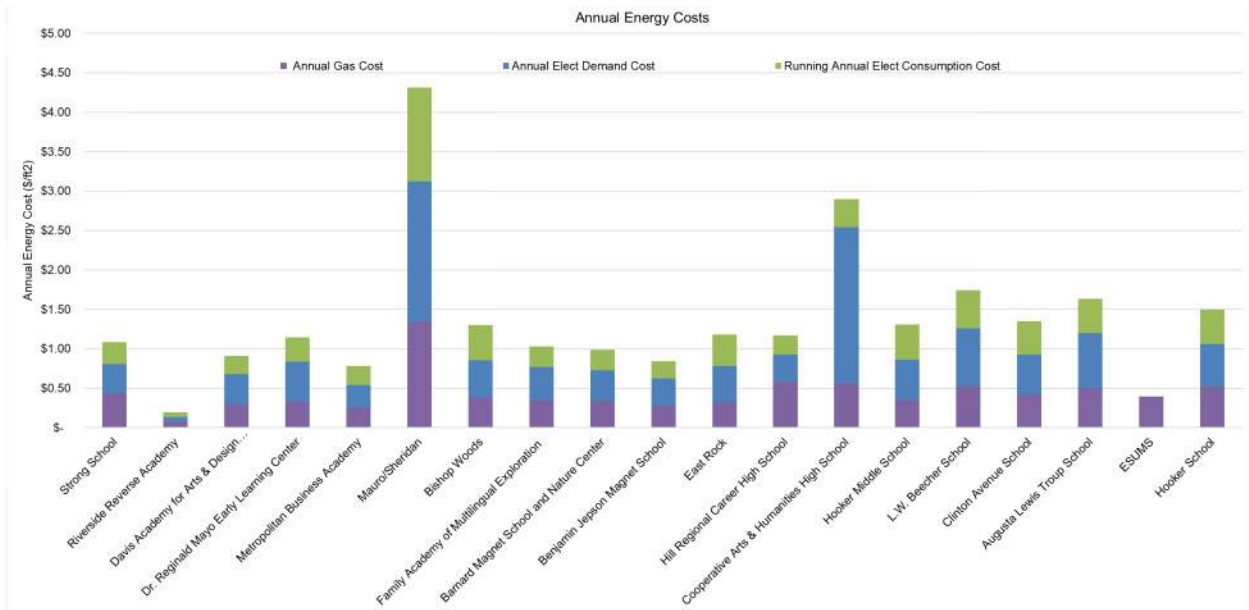
Graph 3: Energy Costs for Modeled Schools

The above table shows the total energy cost for 2019 for all New Haven Schools included within this study. These metrics are broken down in the graph above by school and show the cost of each individual utility (Gas in purple, demand in blue and electric in green). As shown in the graphs, the majority of the energy costs associated with each school are associated with the electric and the demand costs. The average annual energy cost of all buildings and schools in 2019, \$1.79/ft2.

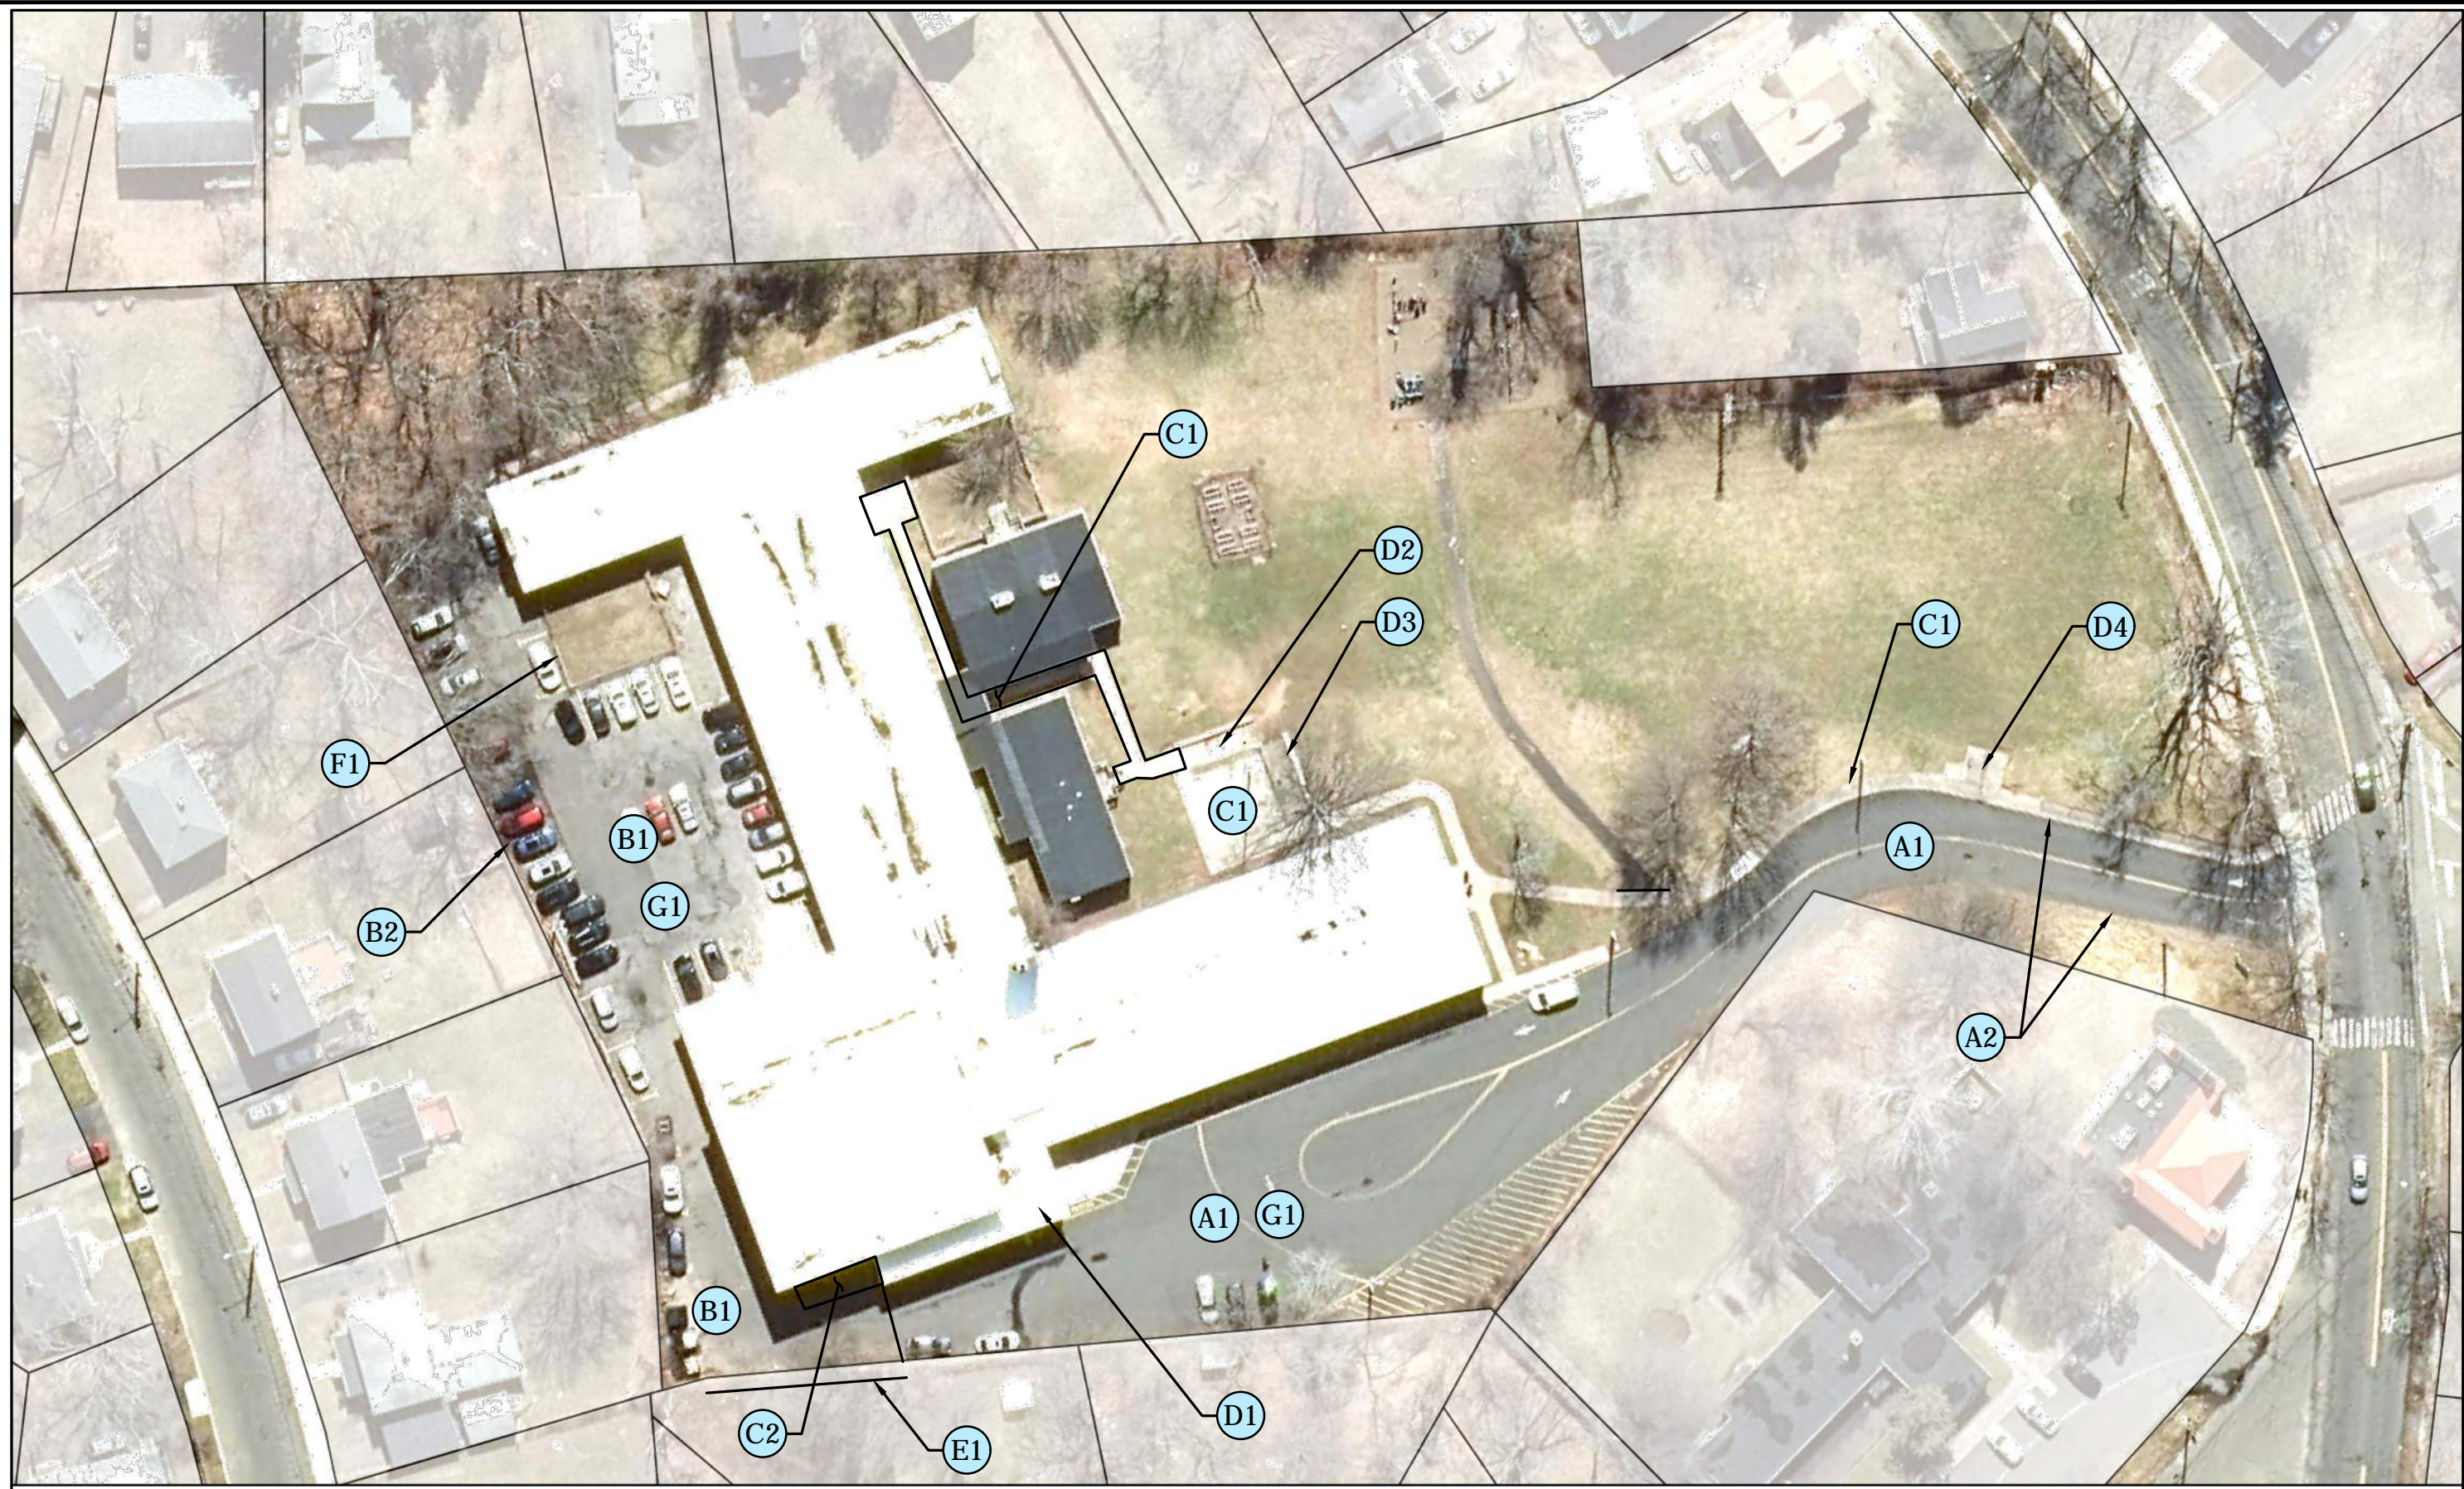
West Rock STREAM Academy

C:\Users\JASON\APPDATA\LOCAL\TEMP\AGENCIEST_1992\SCHOOL_KEY PLANS.DWG Layout 1.dwg WEST ROCK
Printed by: JMOCHHOUSE On this date: Wed, 2022 May 11 - 4:40pm

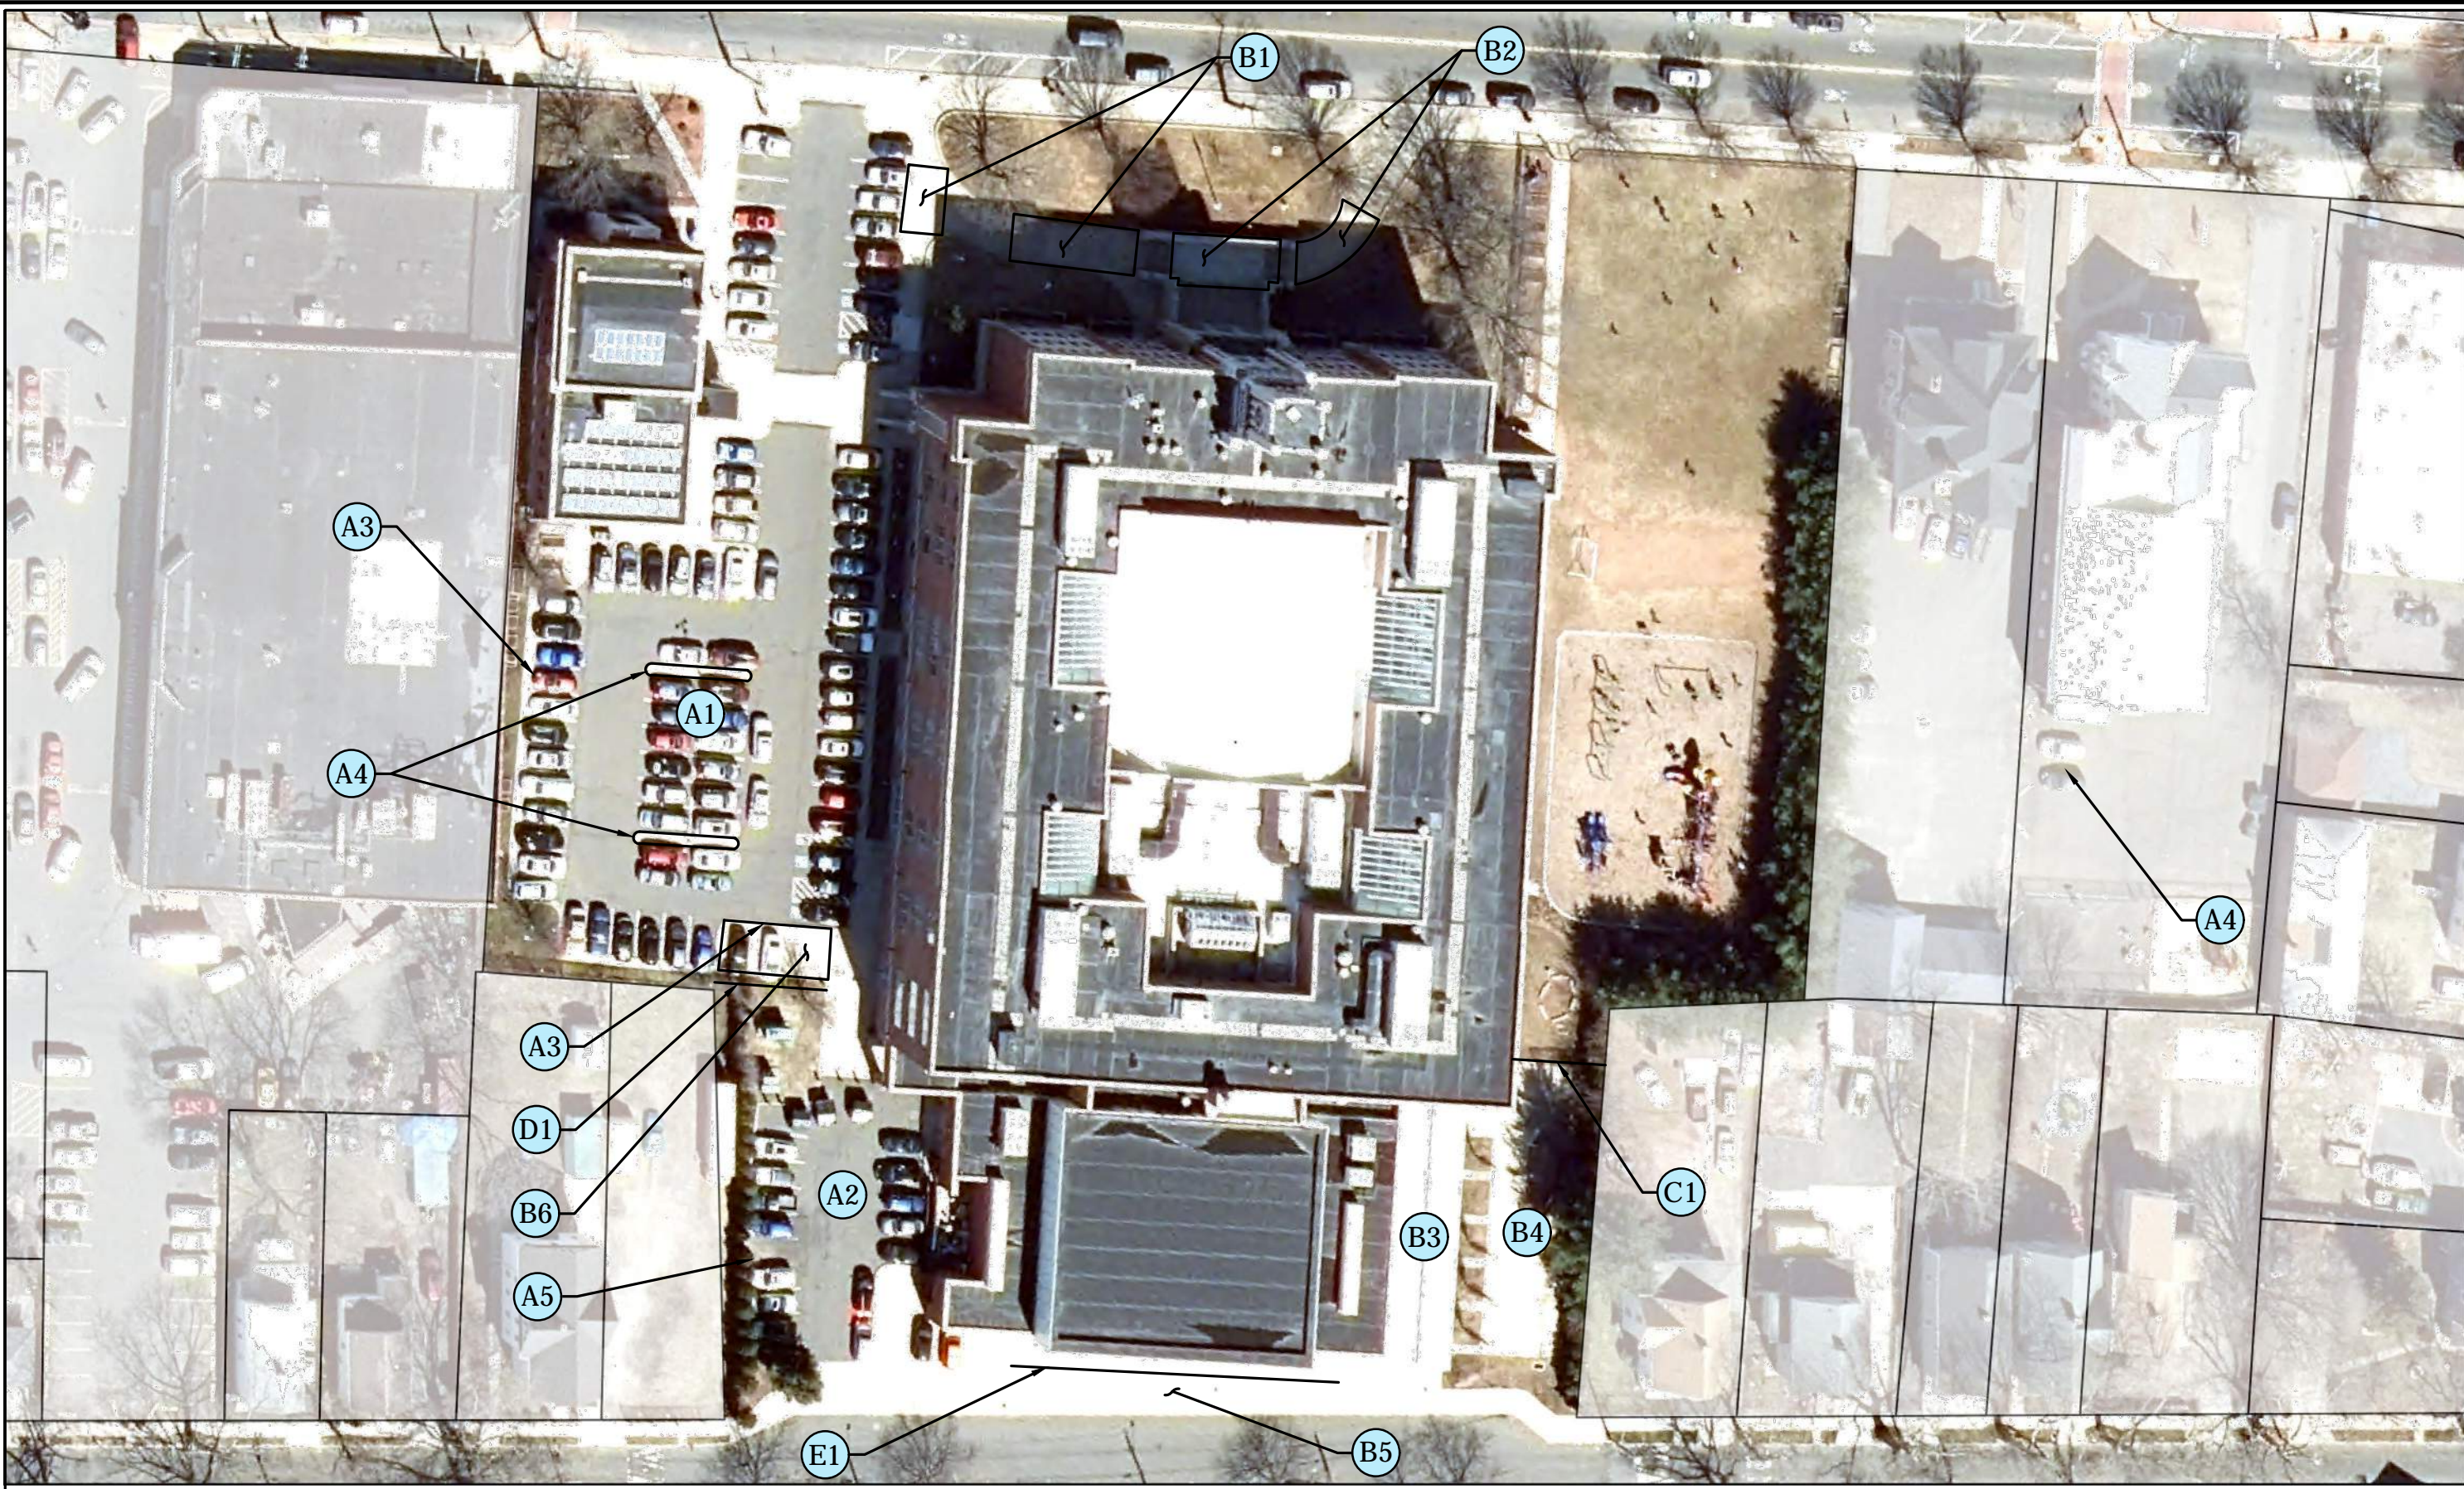
Fair Haven School

C:\Users\JASON\APPDATA\LOCAL\TEMP\AGU\BUSH_27208\SCHOOL_KEY PLANS.DWG Layout 1.dwg FAIR HAVEN SCHOOL
Printed by: JMO@ENRHOUSE On this date: Fri, 2022 March 4 - 12:24pm

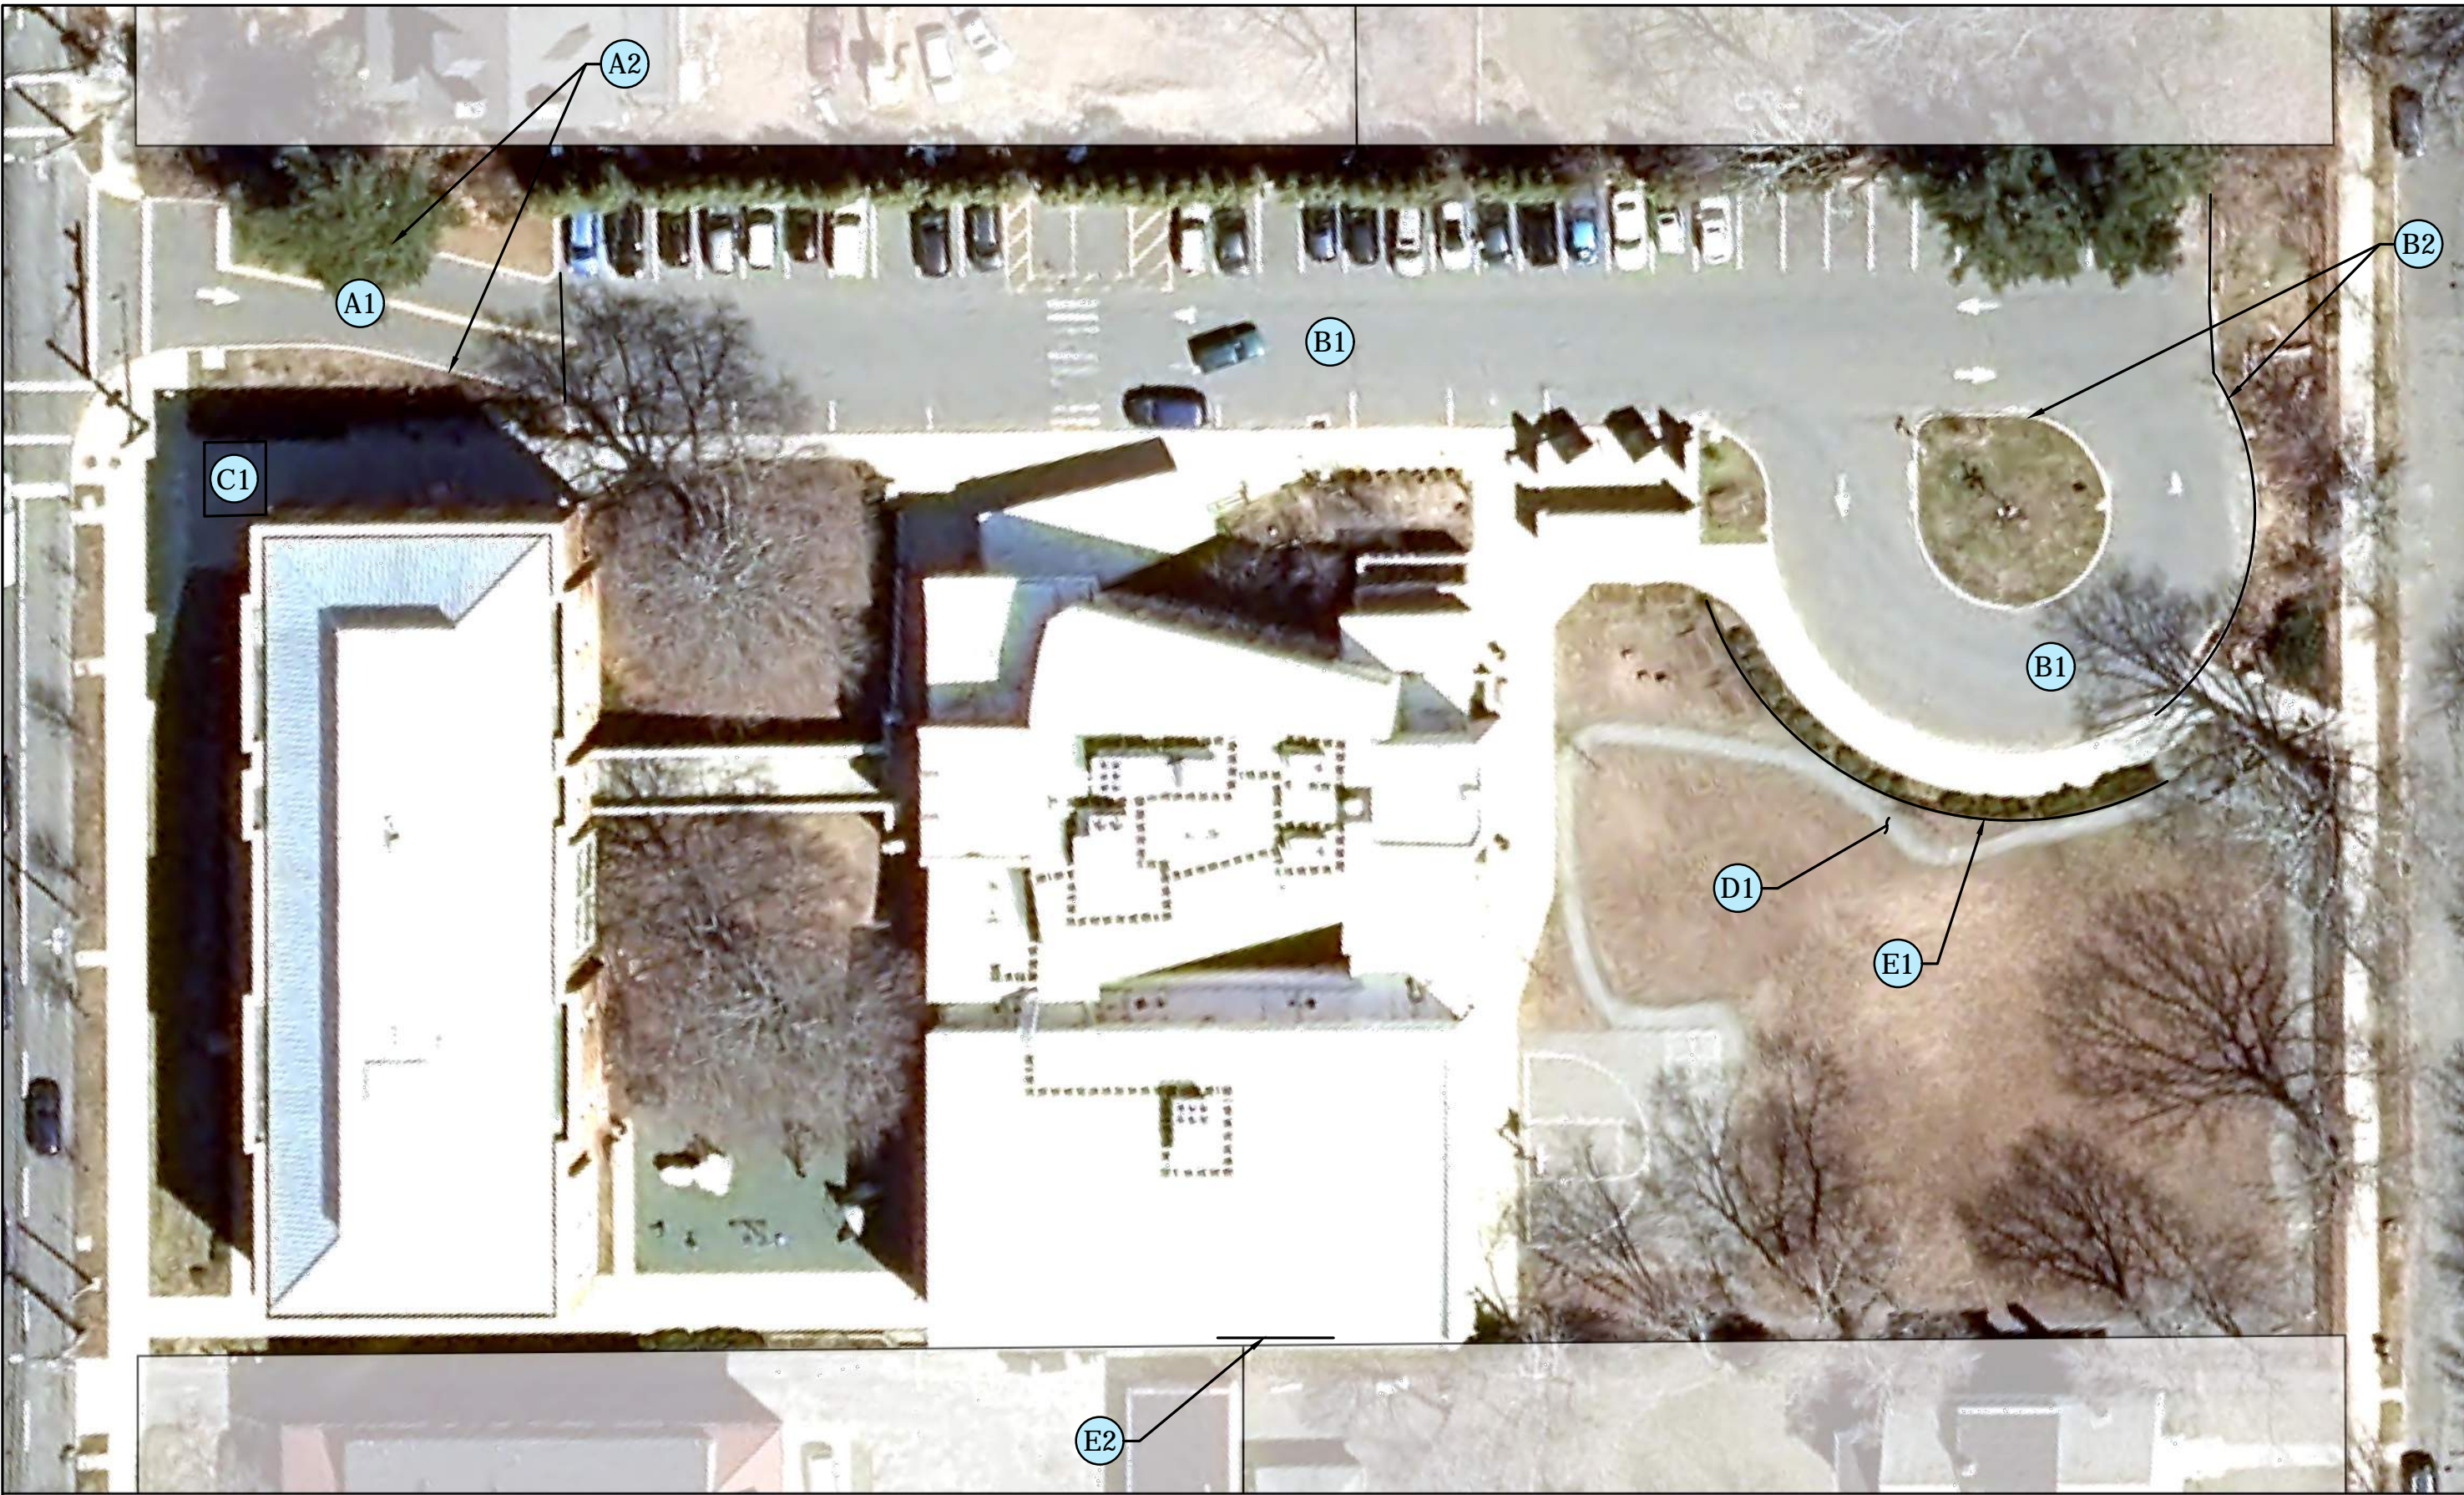
Worthington Hooker School

D. G2060.20- Fences and Gates					
1	Correct Aluminium Fence (6' High) Finish Deterioration by Prep and Refinish	2	Damage/Wear	South of Drive Circle	
2	Correct Aluminium Fence (6' High) Deterioration by Demolition and Replacement	2	Damage/Wear	Along South Property Line	24' Segment

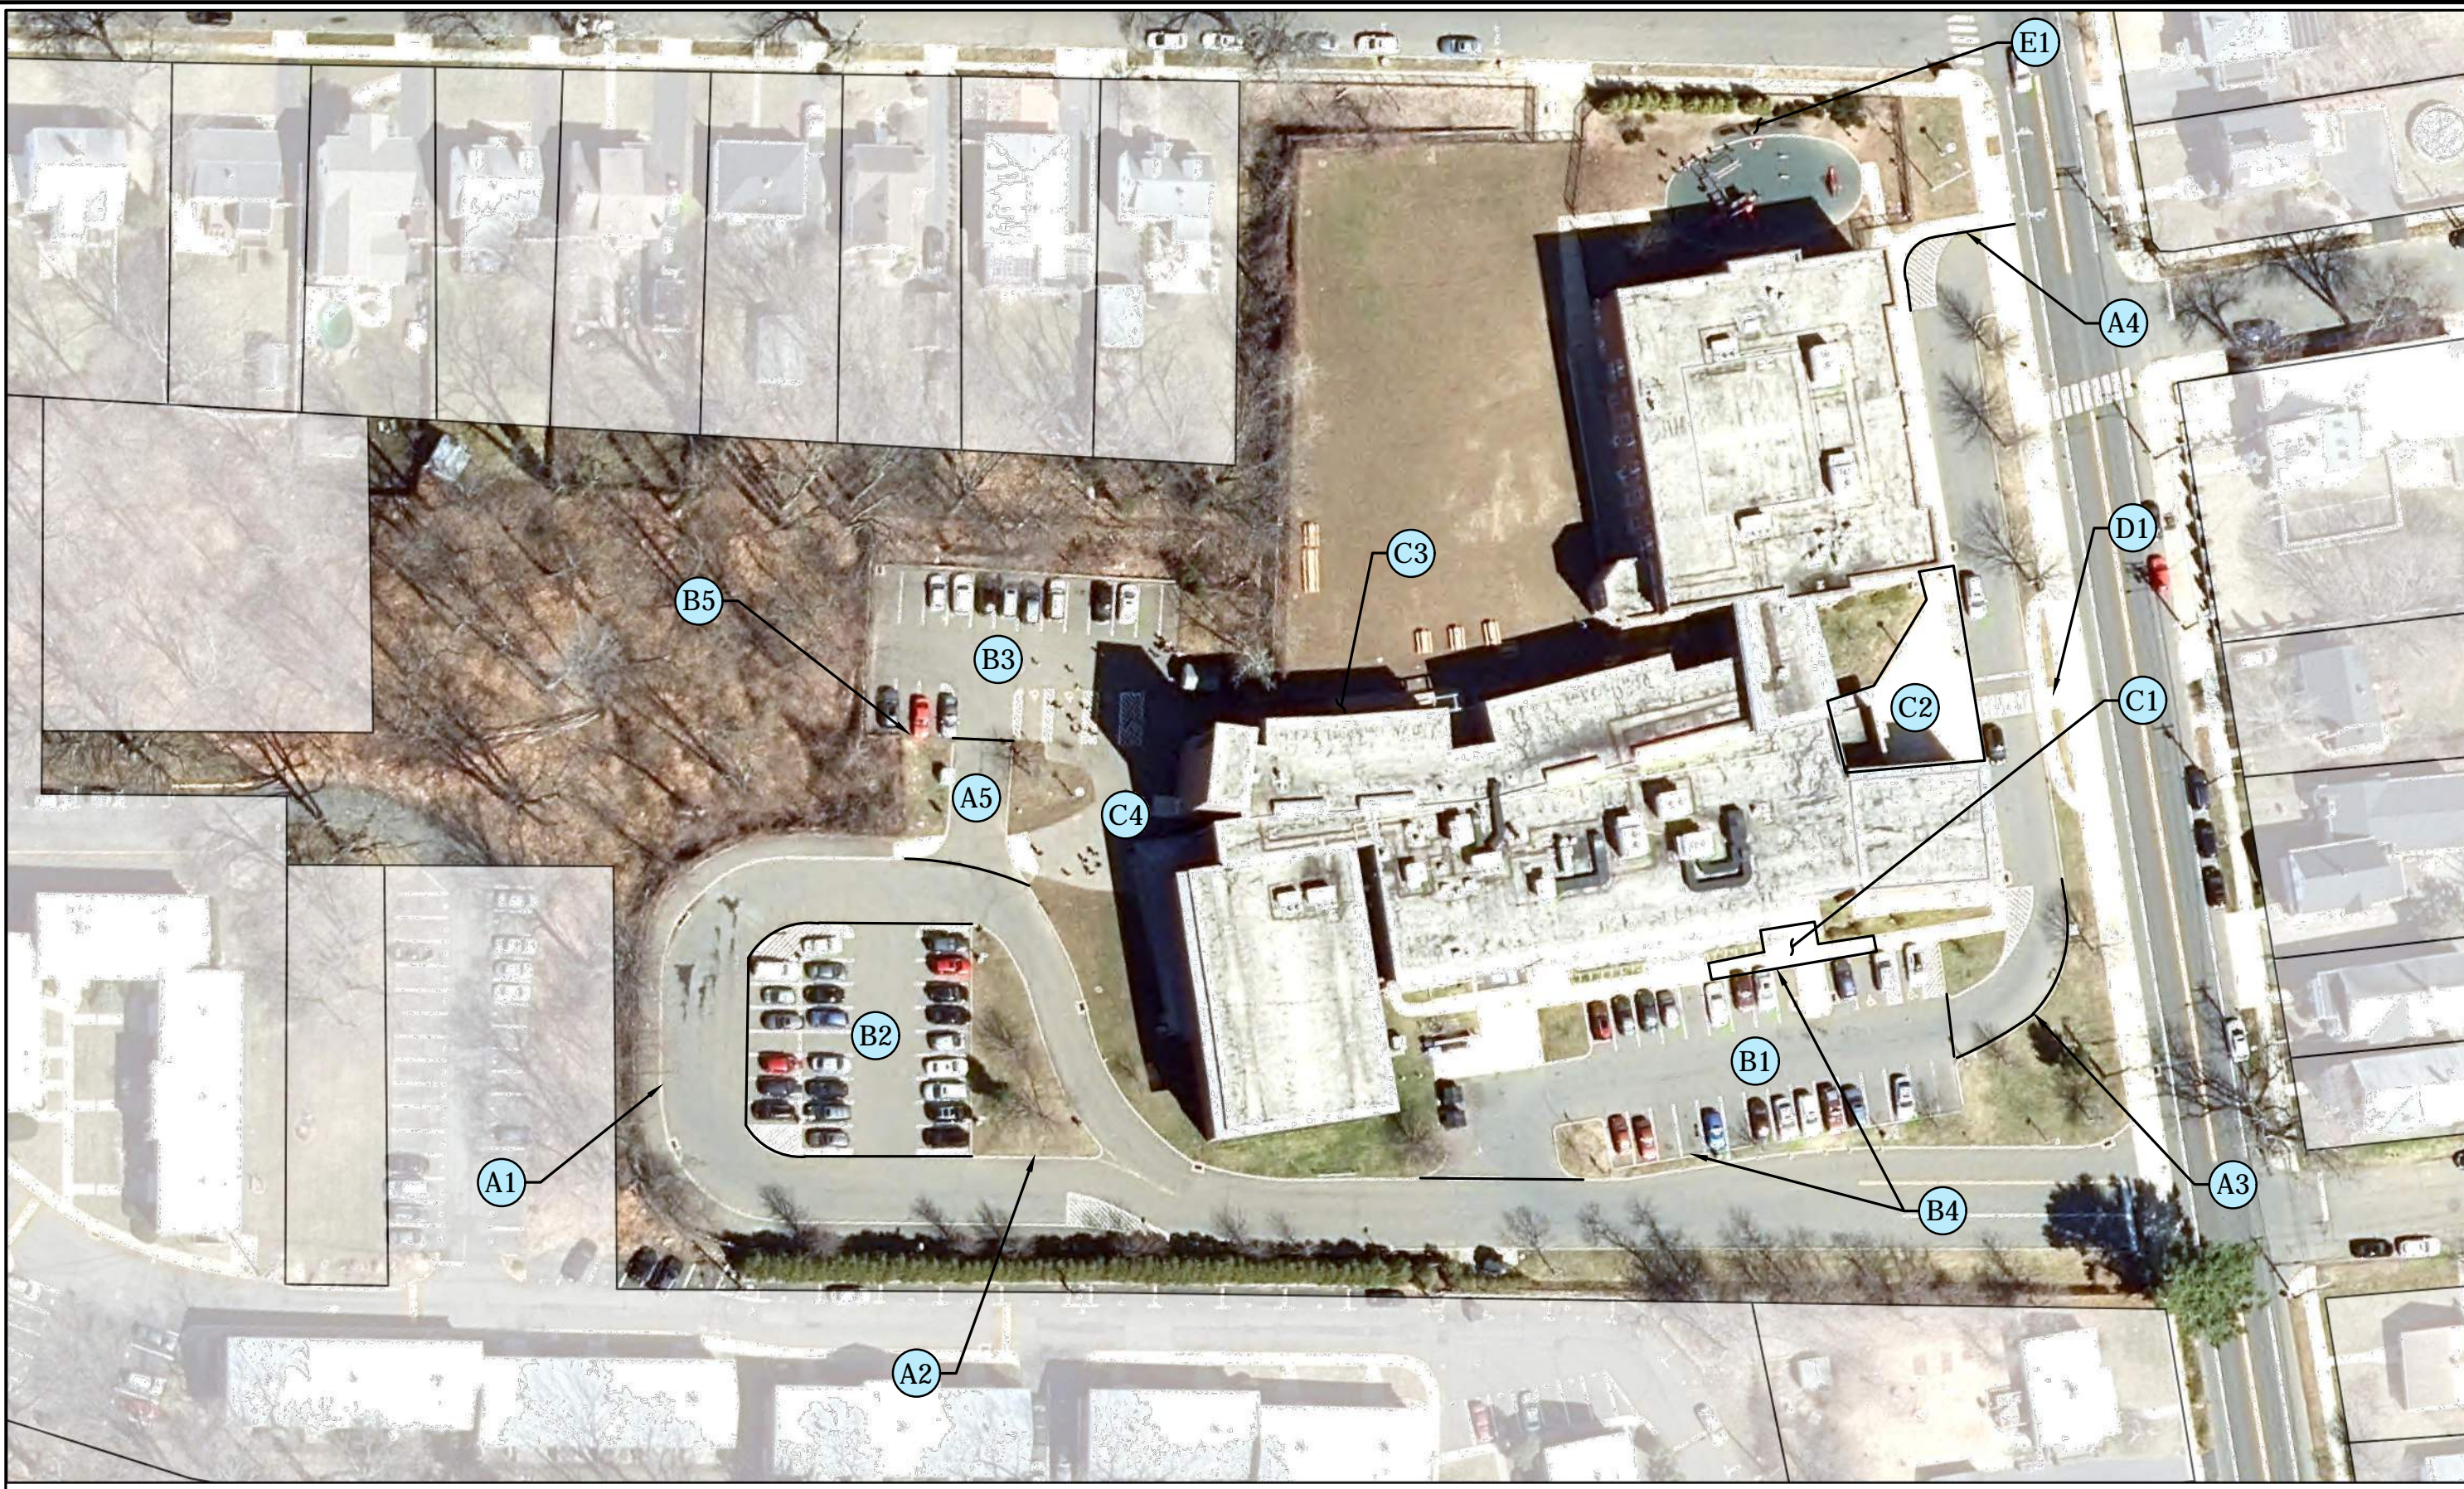
Nathan Hale School

Drawing: W:\CAD\DESIGN\1447\00016-DE-CAD\SCHOOL_KEY PLANS.DWG Layout: NATHAN HALE SCHOOL
Printed by: JMO@HOUSE On this date: Tue, 2022 May 10 - 3:00pm

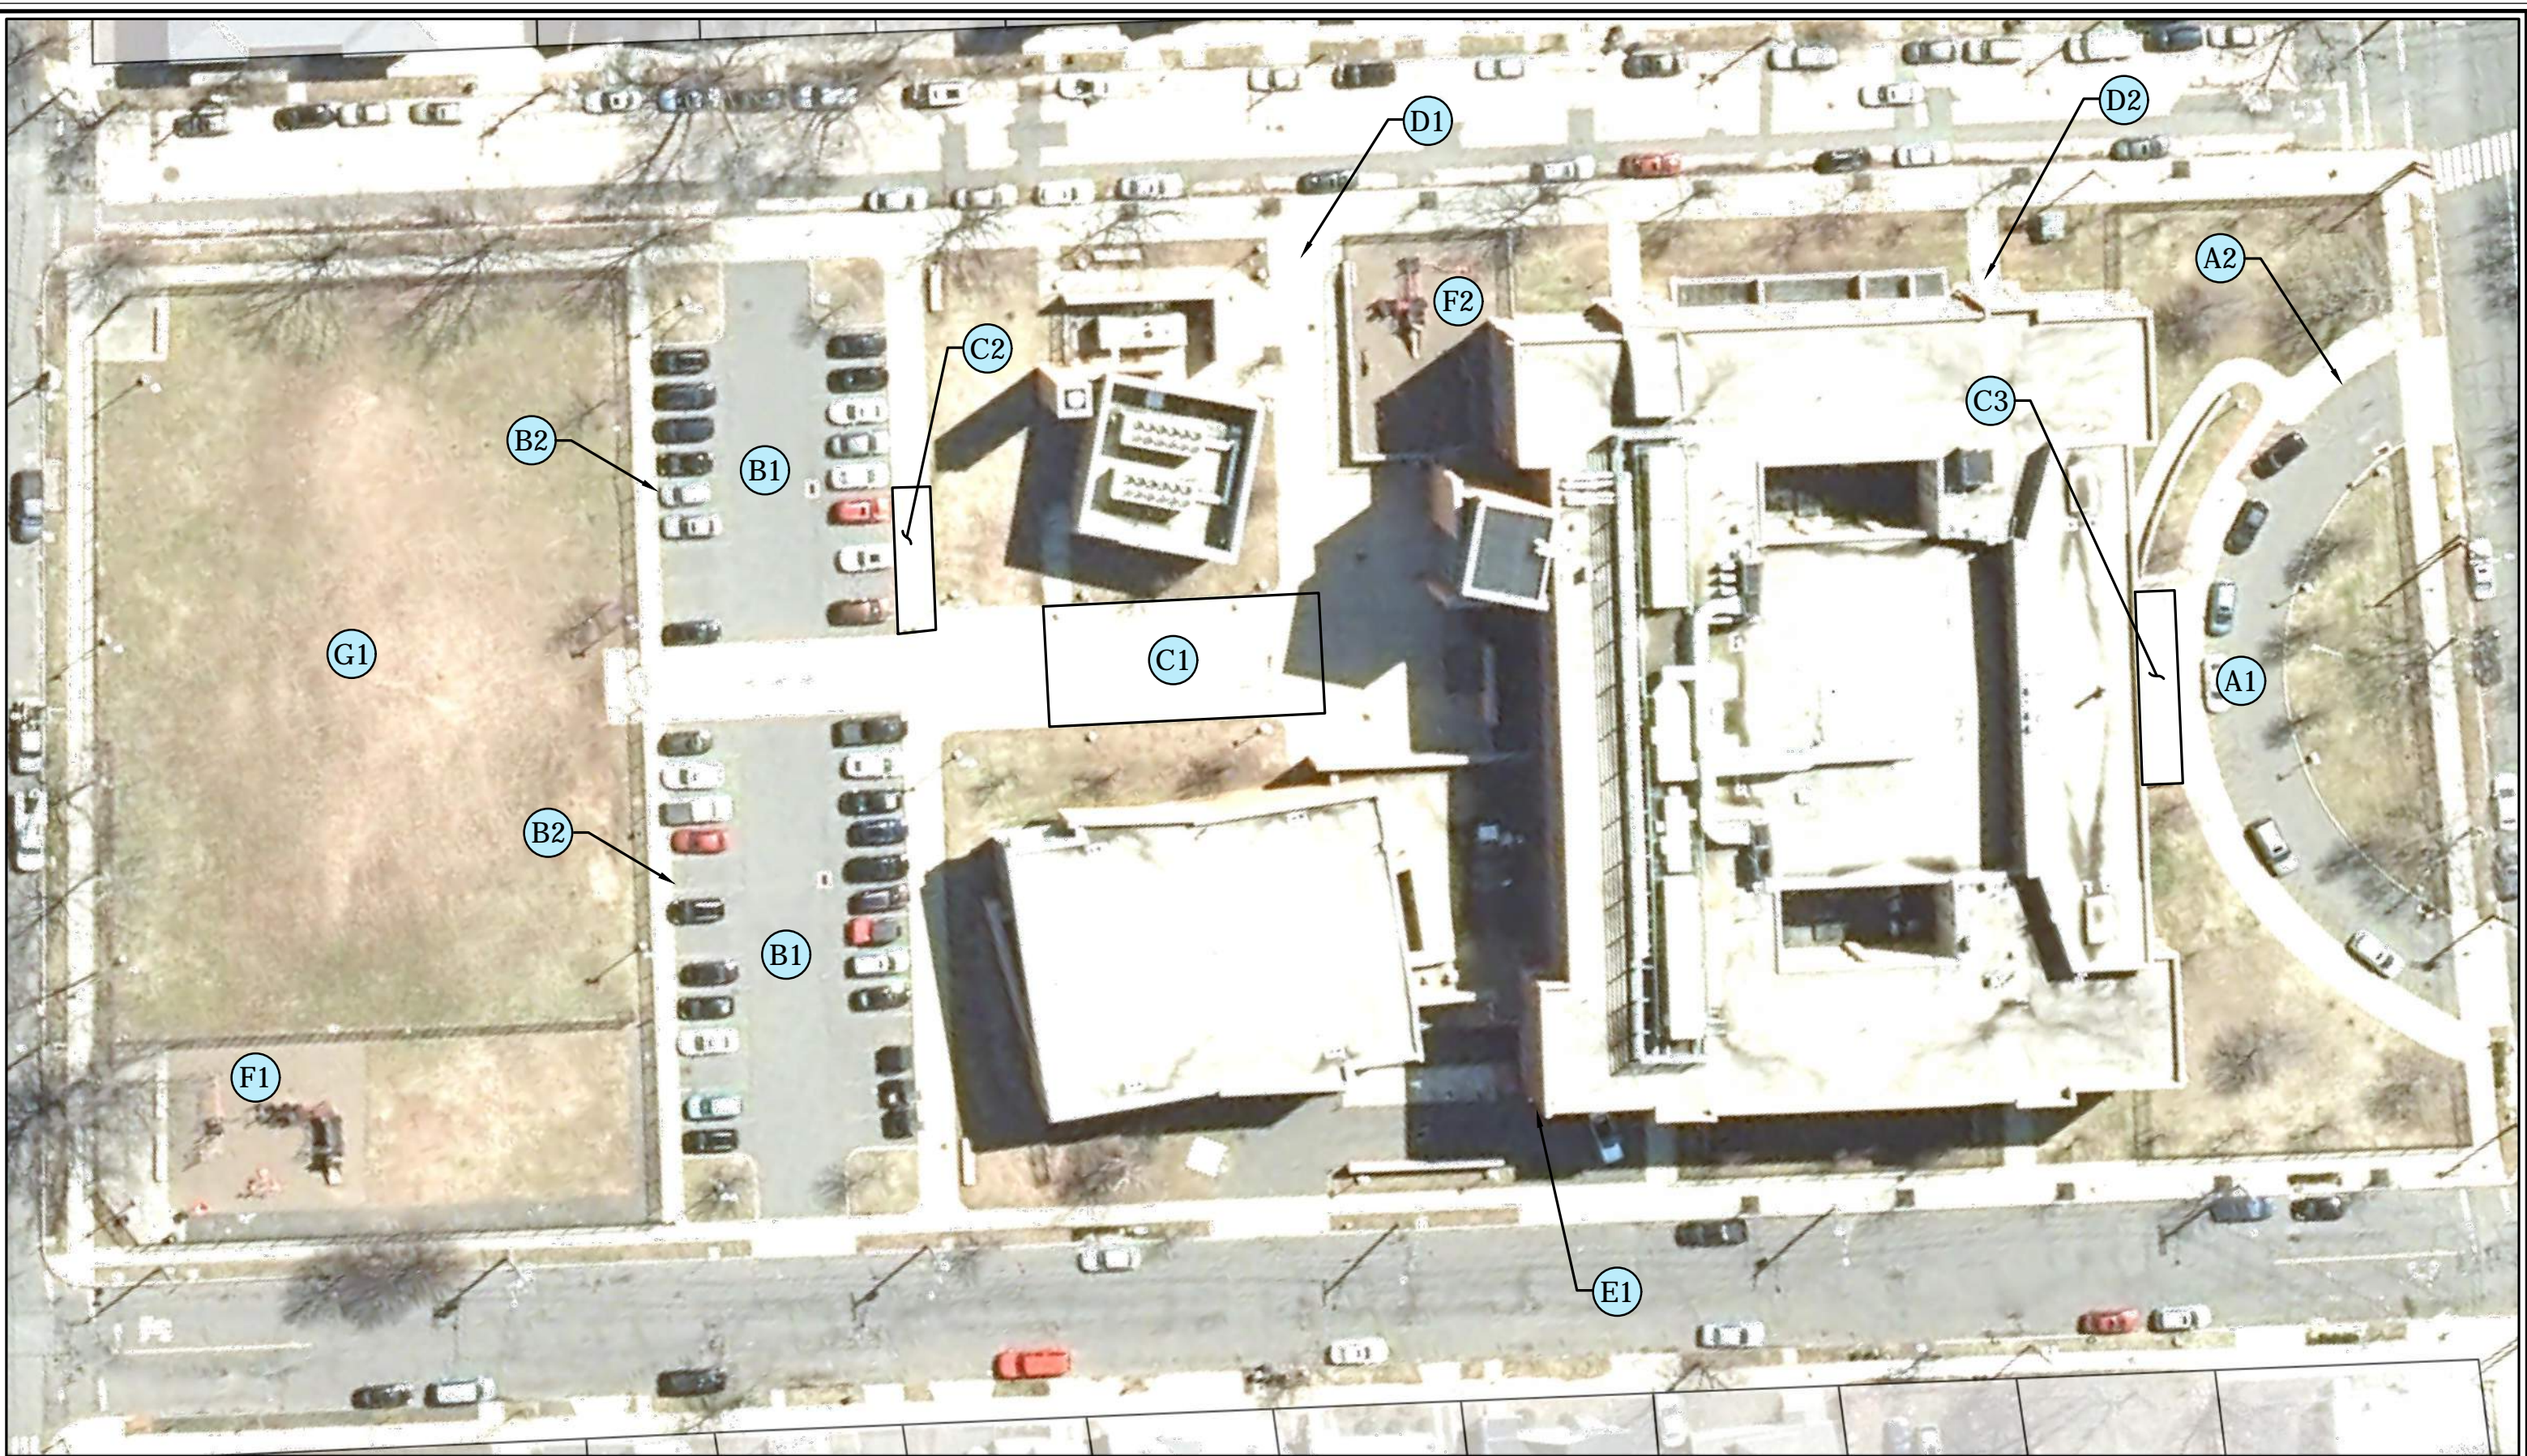
Augusta Lewis Troup Magnet Academy of Science

Drawing: W:\CAD\DESIGN\1447\0016-DE-CAD\SCHOOL KEY PLANS.DWG Layout: TAP AUGUSTA LEWIS TROUP
Printed by: JIMORHOUSE On this date: Wed, 2022 May 18 - 12:12pm
