**NEW HAVEN
PUBLIC SCHOOLS
LONG-RANGE
FACILITIES
PLANNING STUDY**

Final 12-04-23

SECTION 1: DISTRICT VISION & STUDY PURPOSE

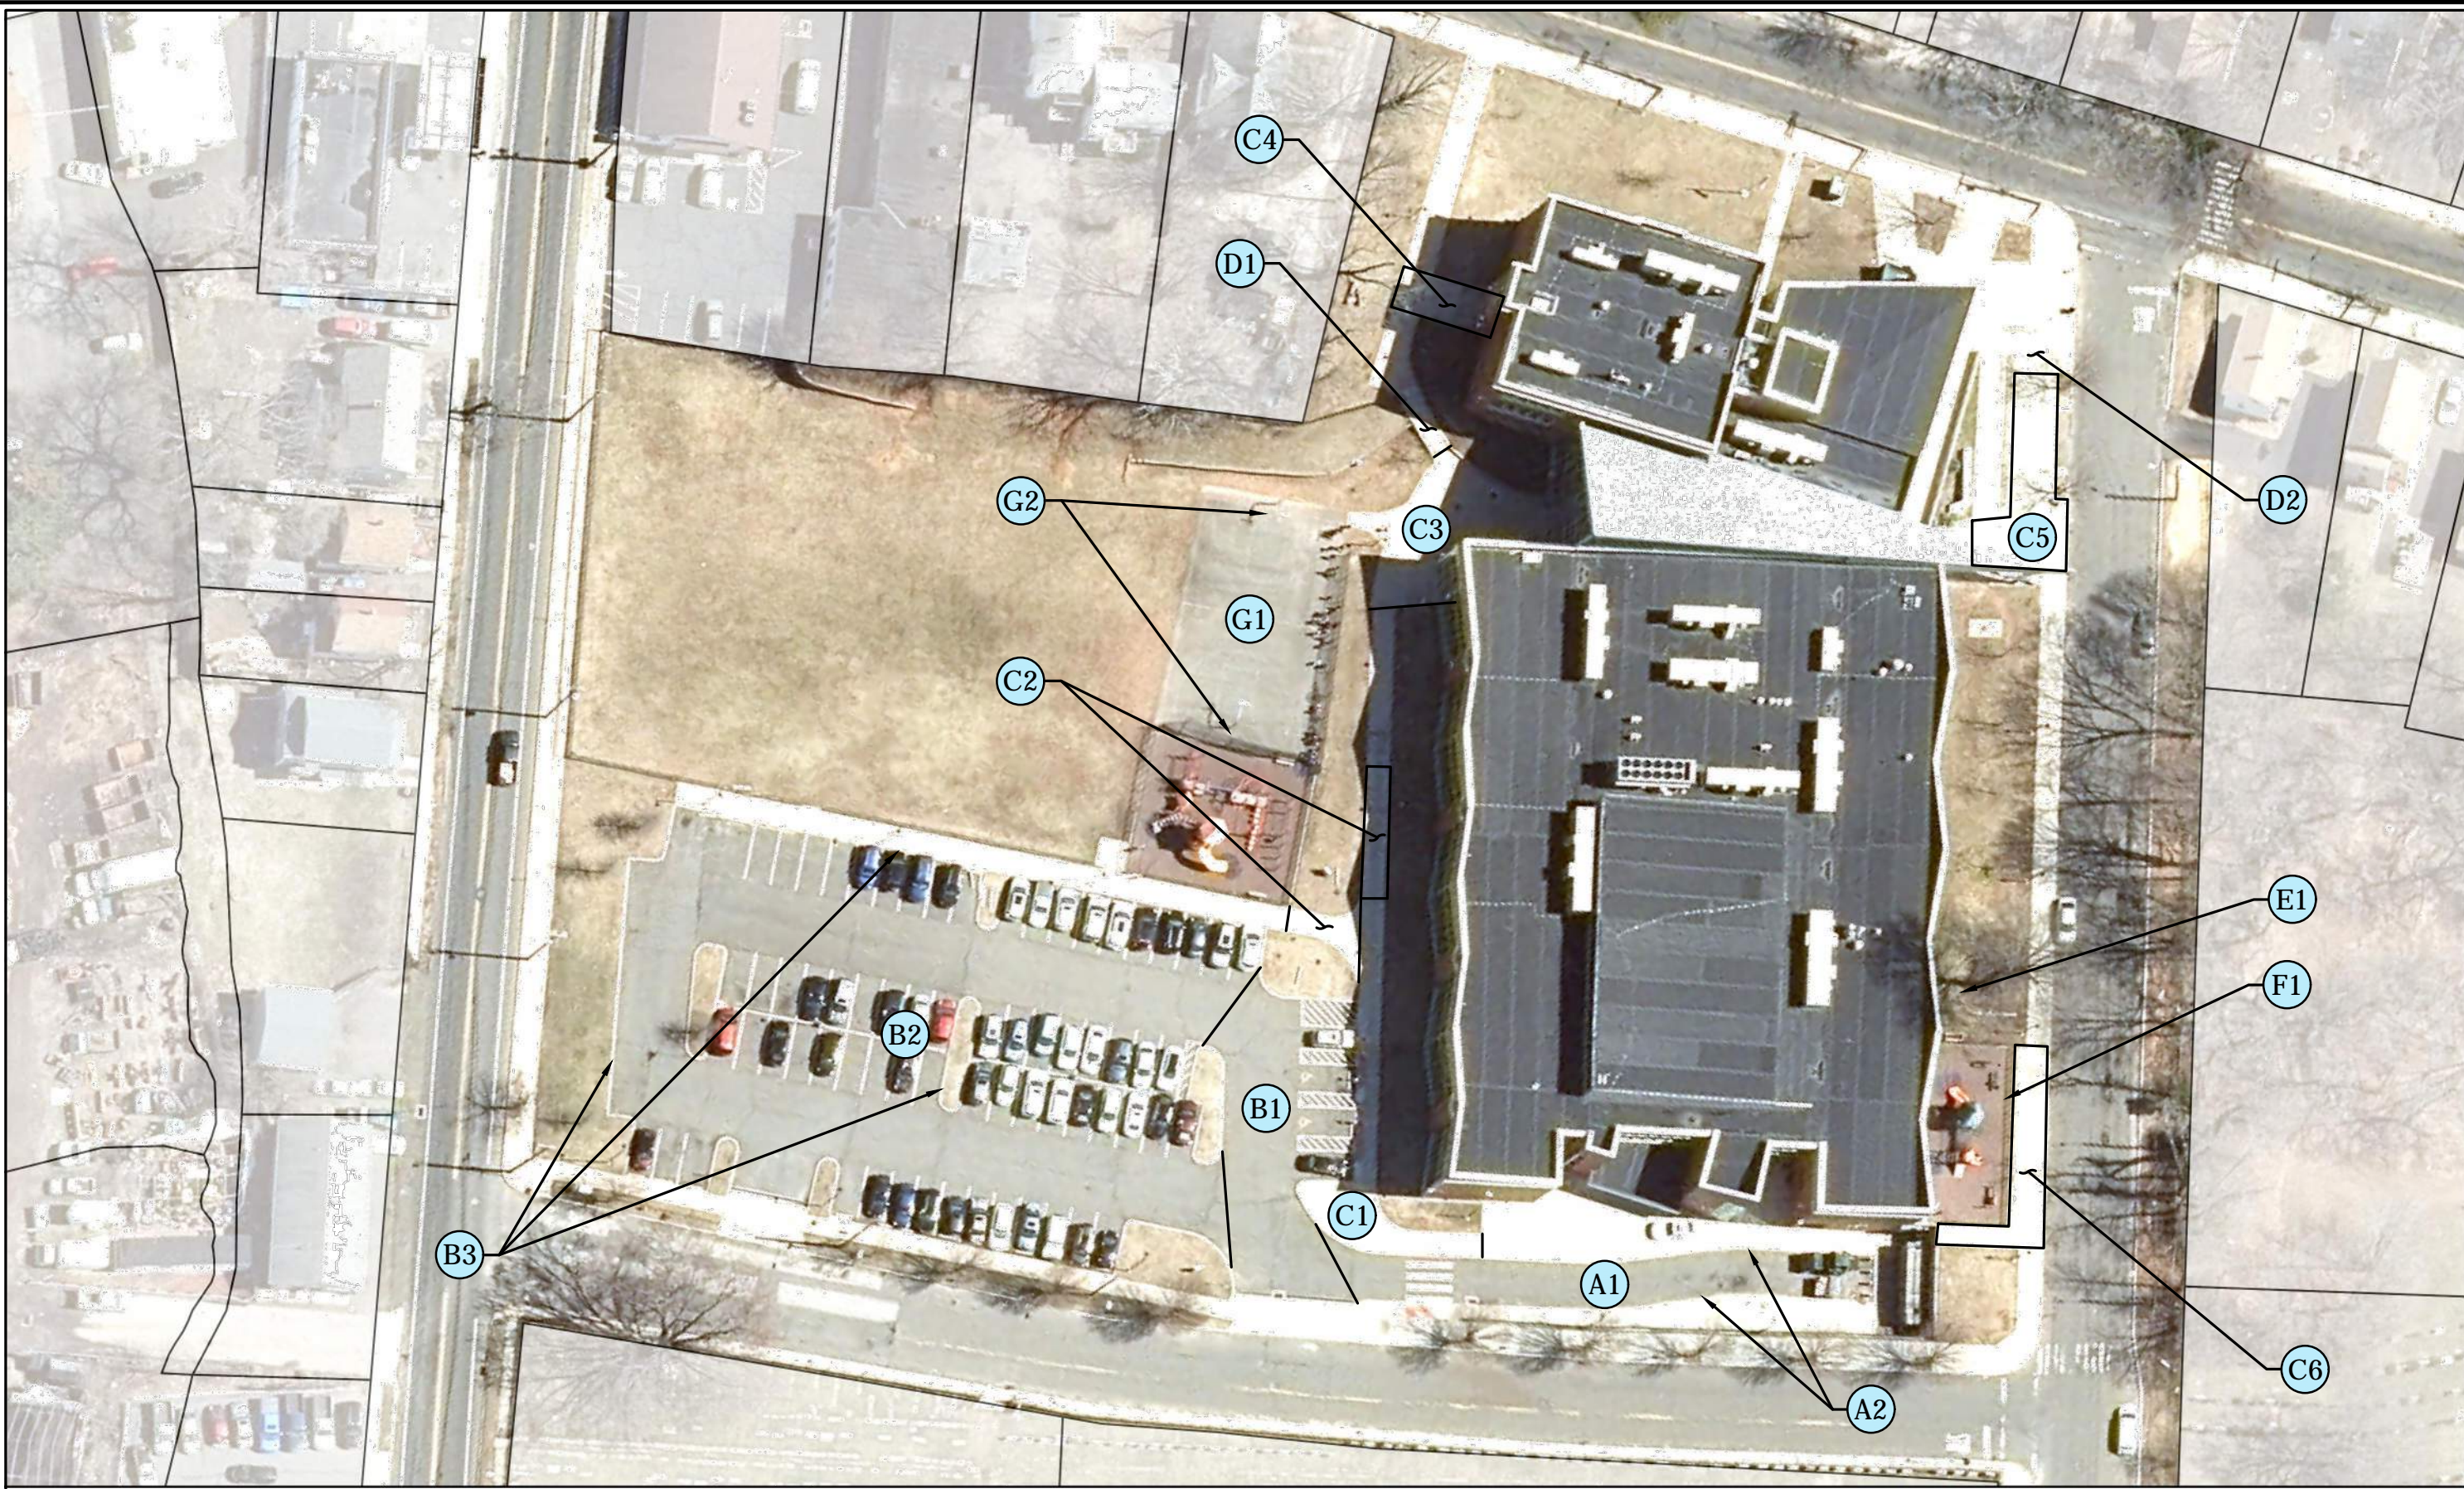
L.W. Beecher Museum Magnet School of Arts and Sciences

There is 1 parking lot to the east corner of the site and a bus drop off that surrounds the main parking lot. The paved areas are in fair to good condition with evidence of cracking and pavement section deterioration. The paved drive isles are in good condition. Sidewalk surfaces are in good condition with small areas of damage. Site lighting seems to be adequate, but a photometric plan should be done to see where deficiencies exist. Fencing is provided around the playground and play area. That fencing is in good condition. Storm water from the roofs, landscaped areas, and paved areas flows into on site inlets and catch basins with underground piping connected to the municipal storm water management system.

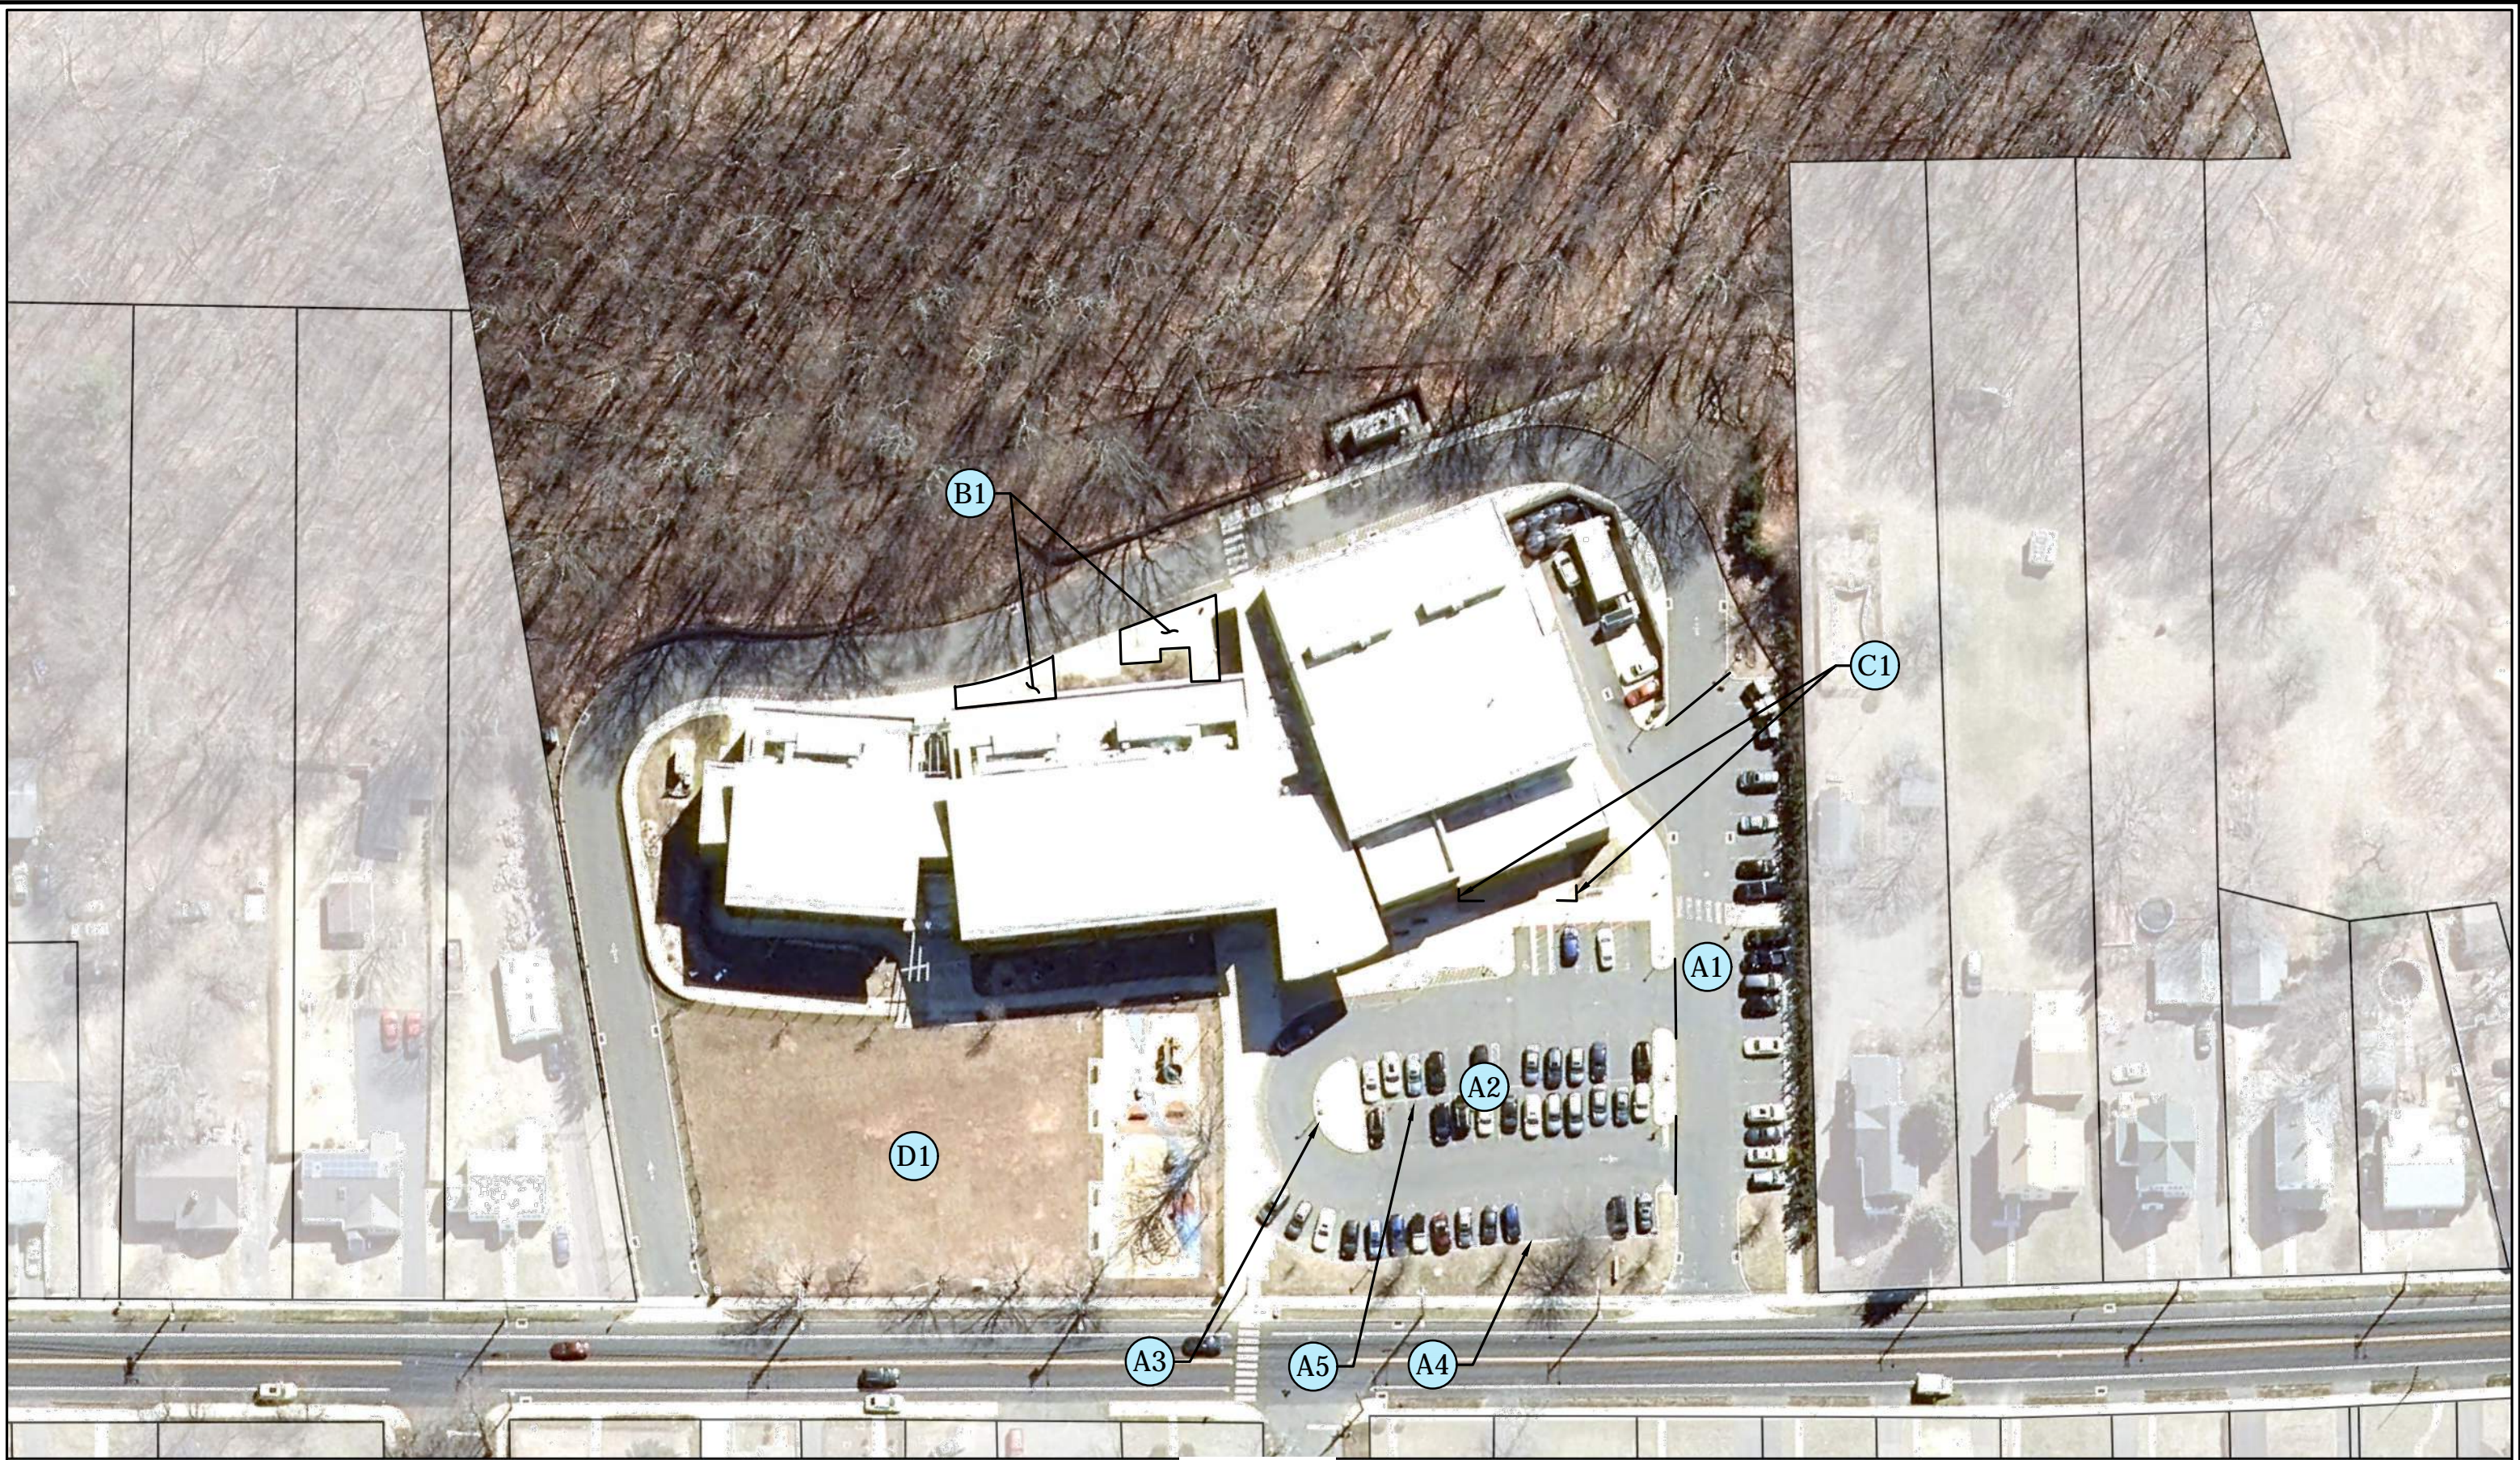
Bishop Woods Architecture and Design Magnet School

There are two parking lots, one to the south of the school and the other to the east. A bus drop off wraps around the parking lot to the east of the school. A access drive wraps the west and south sides of the school. The paved areas are in poor condition with evidence of cracking and pavement section deterioration. The paved drive isles are in poor to good condition. Sidewalk surfaces are in good condition. Site lighting seems to be adequate, but a photometric plan should be done to see where deficiencies exist. Fencing is provided around the playground and the basketball court. Around the playground is in good condition and around the basketball court is in poor condition. Storm water from the roofs, landscaped areas, and paved areas flows into on site inlets and catch basins with underground piping connected to the municipal storm water management system.

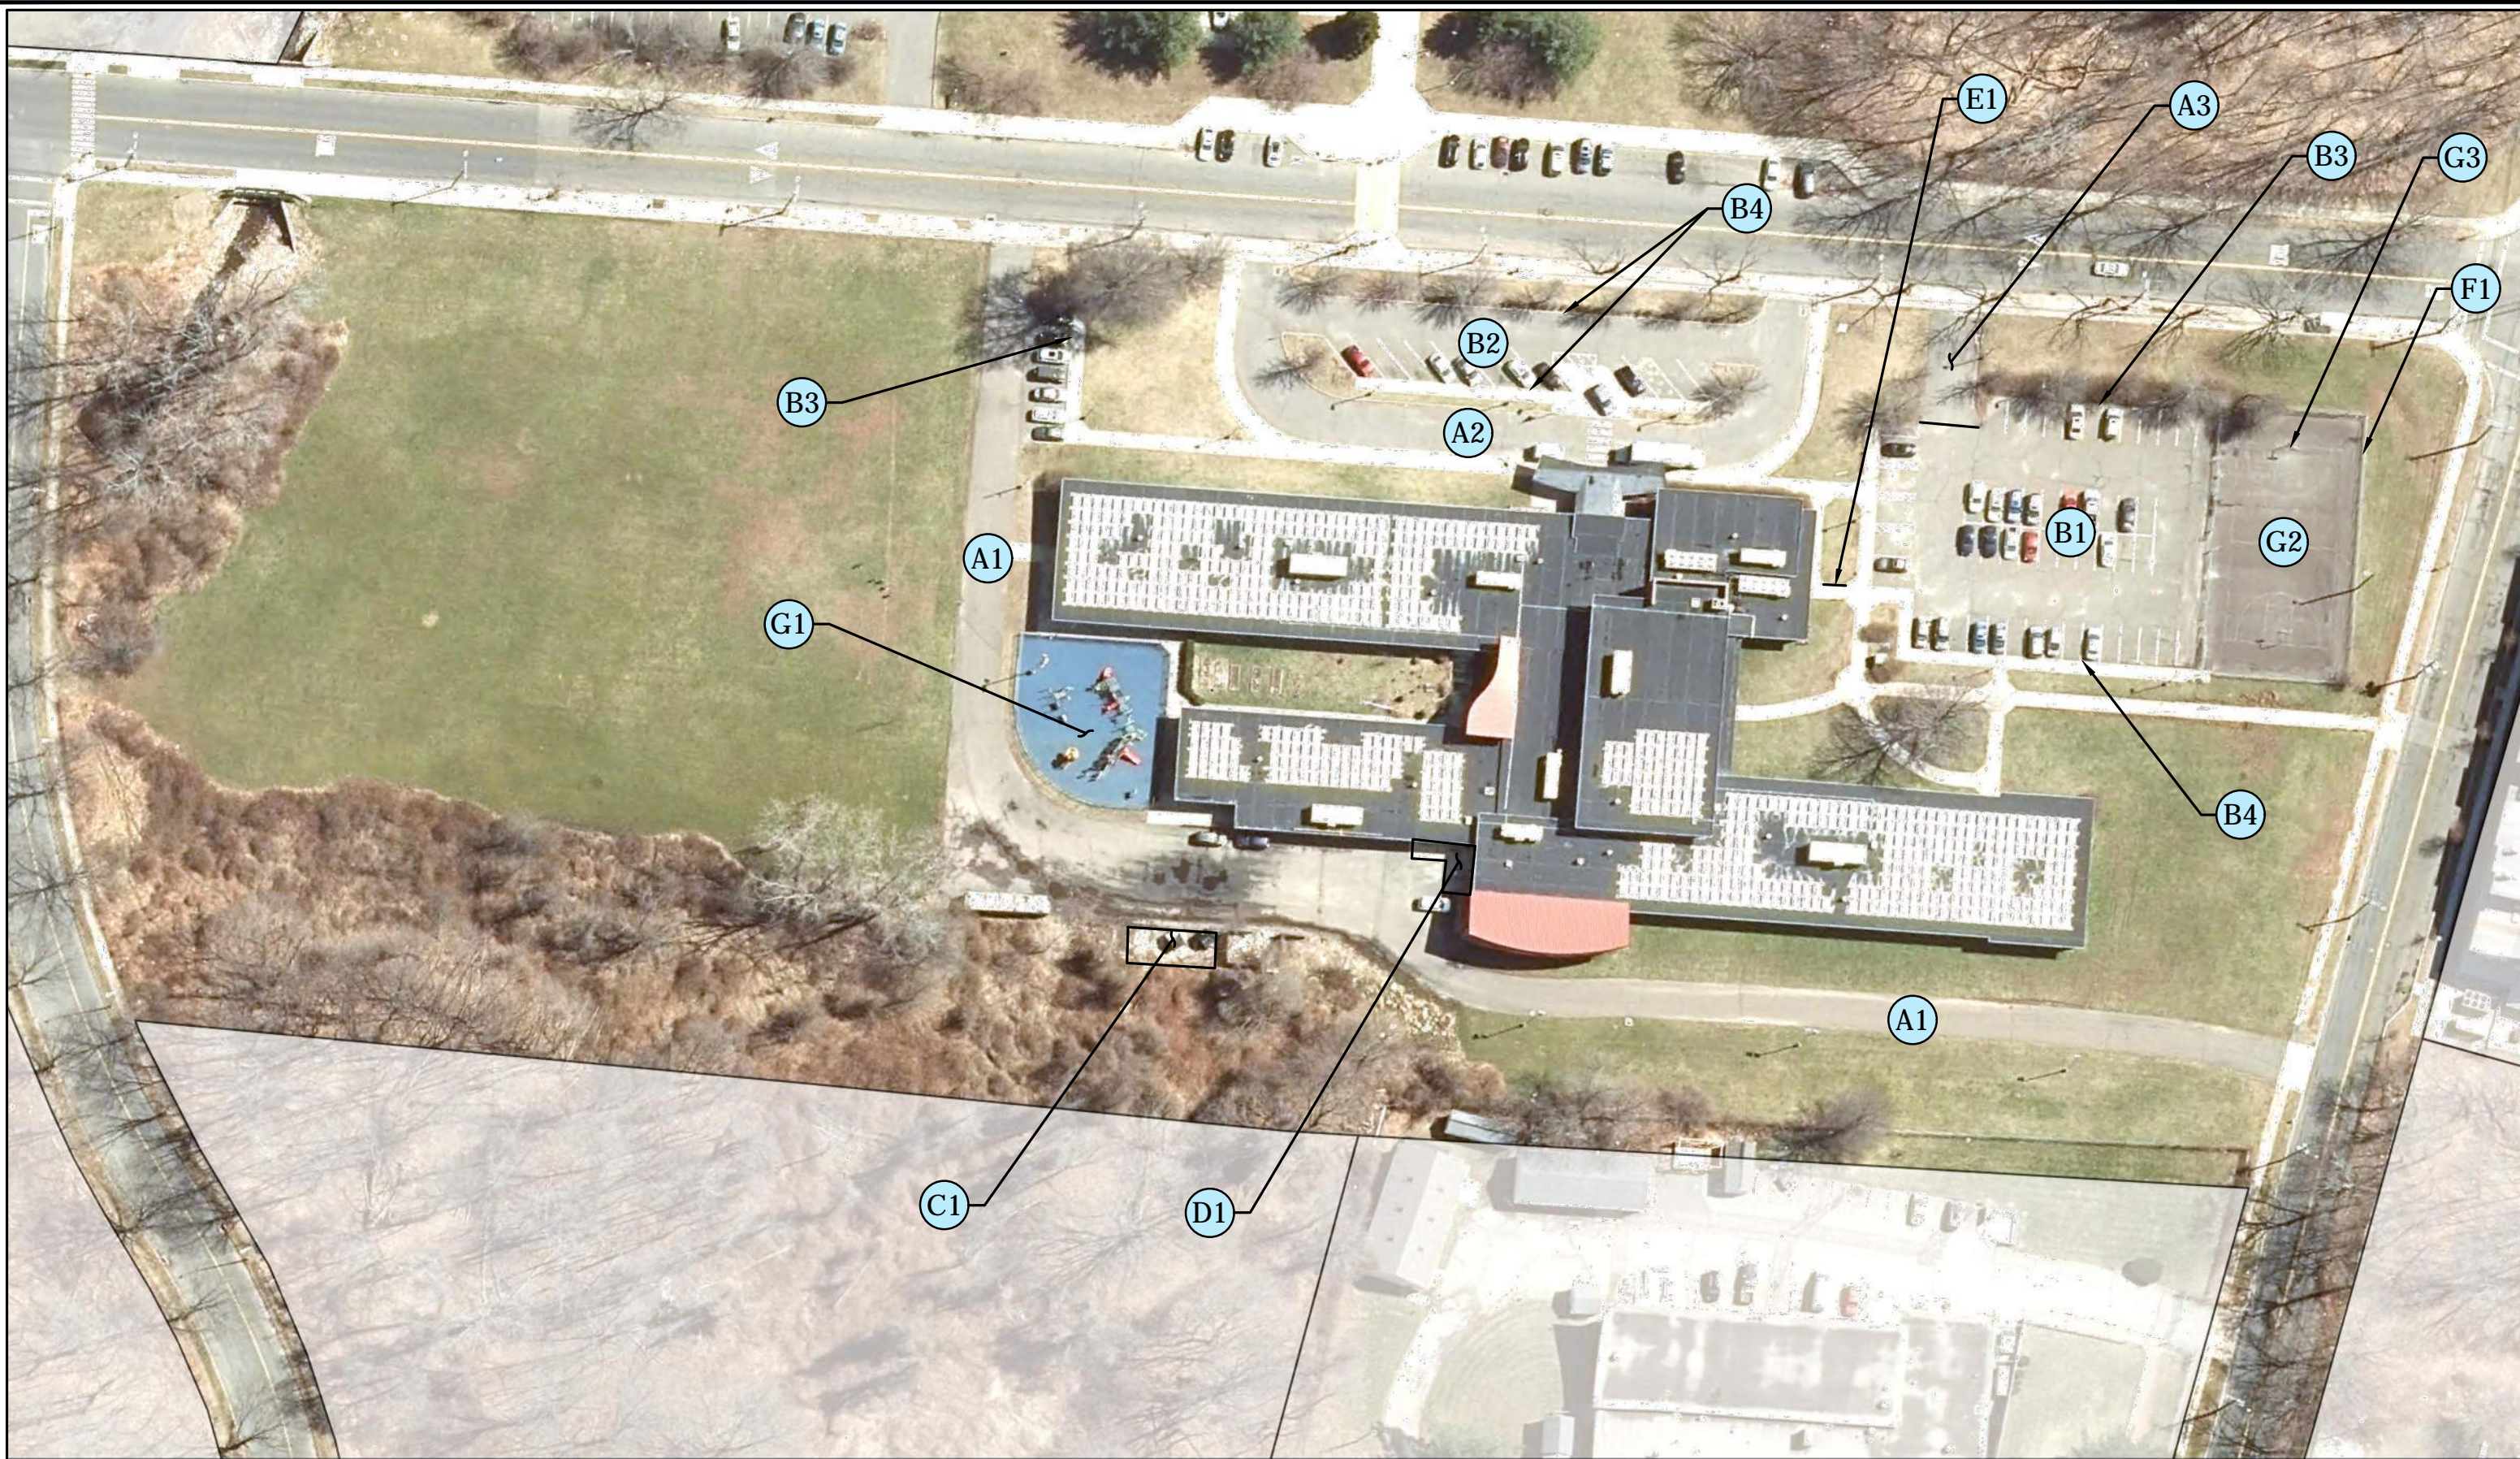
Brennan-Rogers School of Communication and Media (West)

There is 1 parking lot to the north corner of the site and a bus drop off that loop around the school. The paved areas are in poor to fair condition with evidence of heavy cracking and pavement section deterioration. The paved drive isles are in poor to fair condition. Sidewalk surfaces are in poor to good condition with areas of damage. Site lighting seems to be adequate, but a photometric plan should be done to see where deficiencies exist. There is one broken pole light that needs to be replaced. Fencing is provided around the two playgrounds. That fencing is in fair to good condition. Storm water from the roofs, landscaped areas, and paved areas flows into on site inlets and catch basins with underground piping connected to the municipal storm water management system.

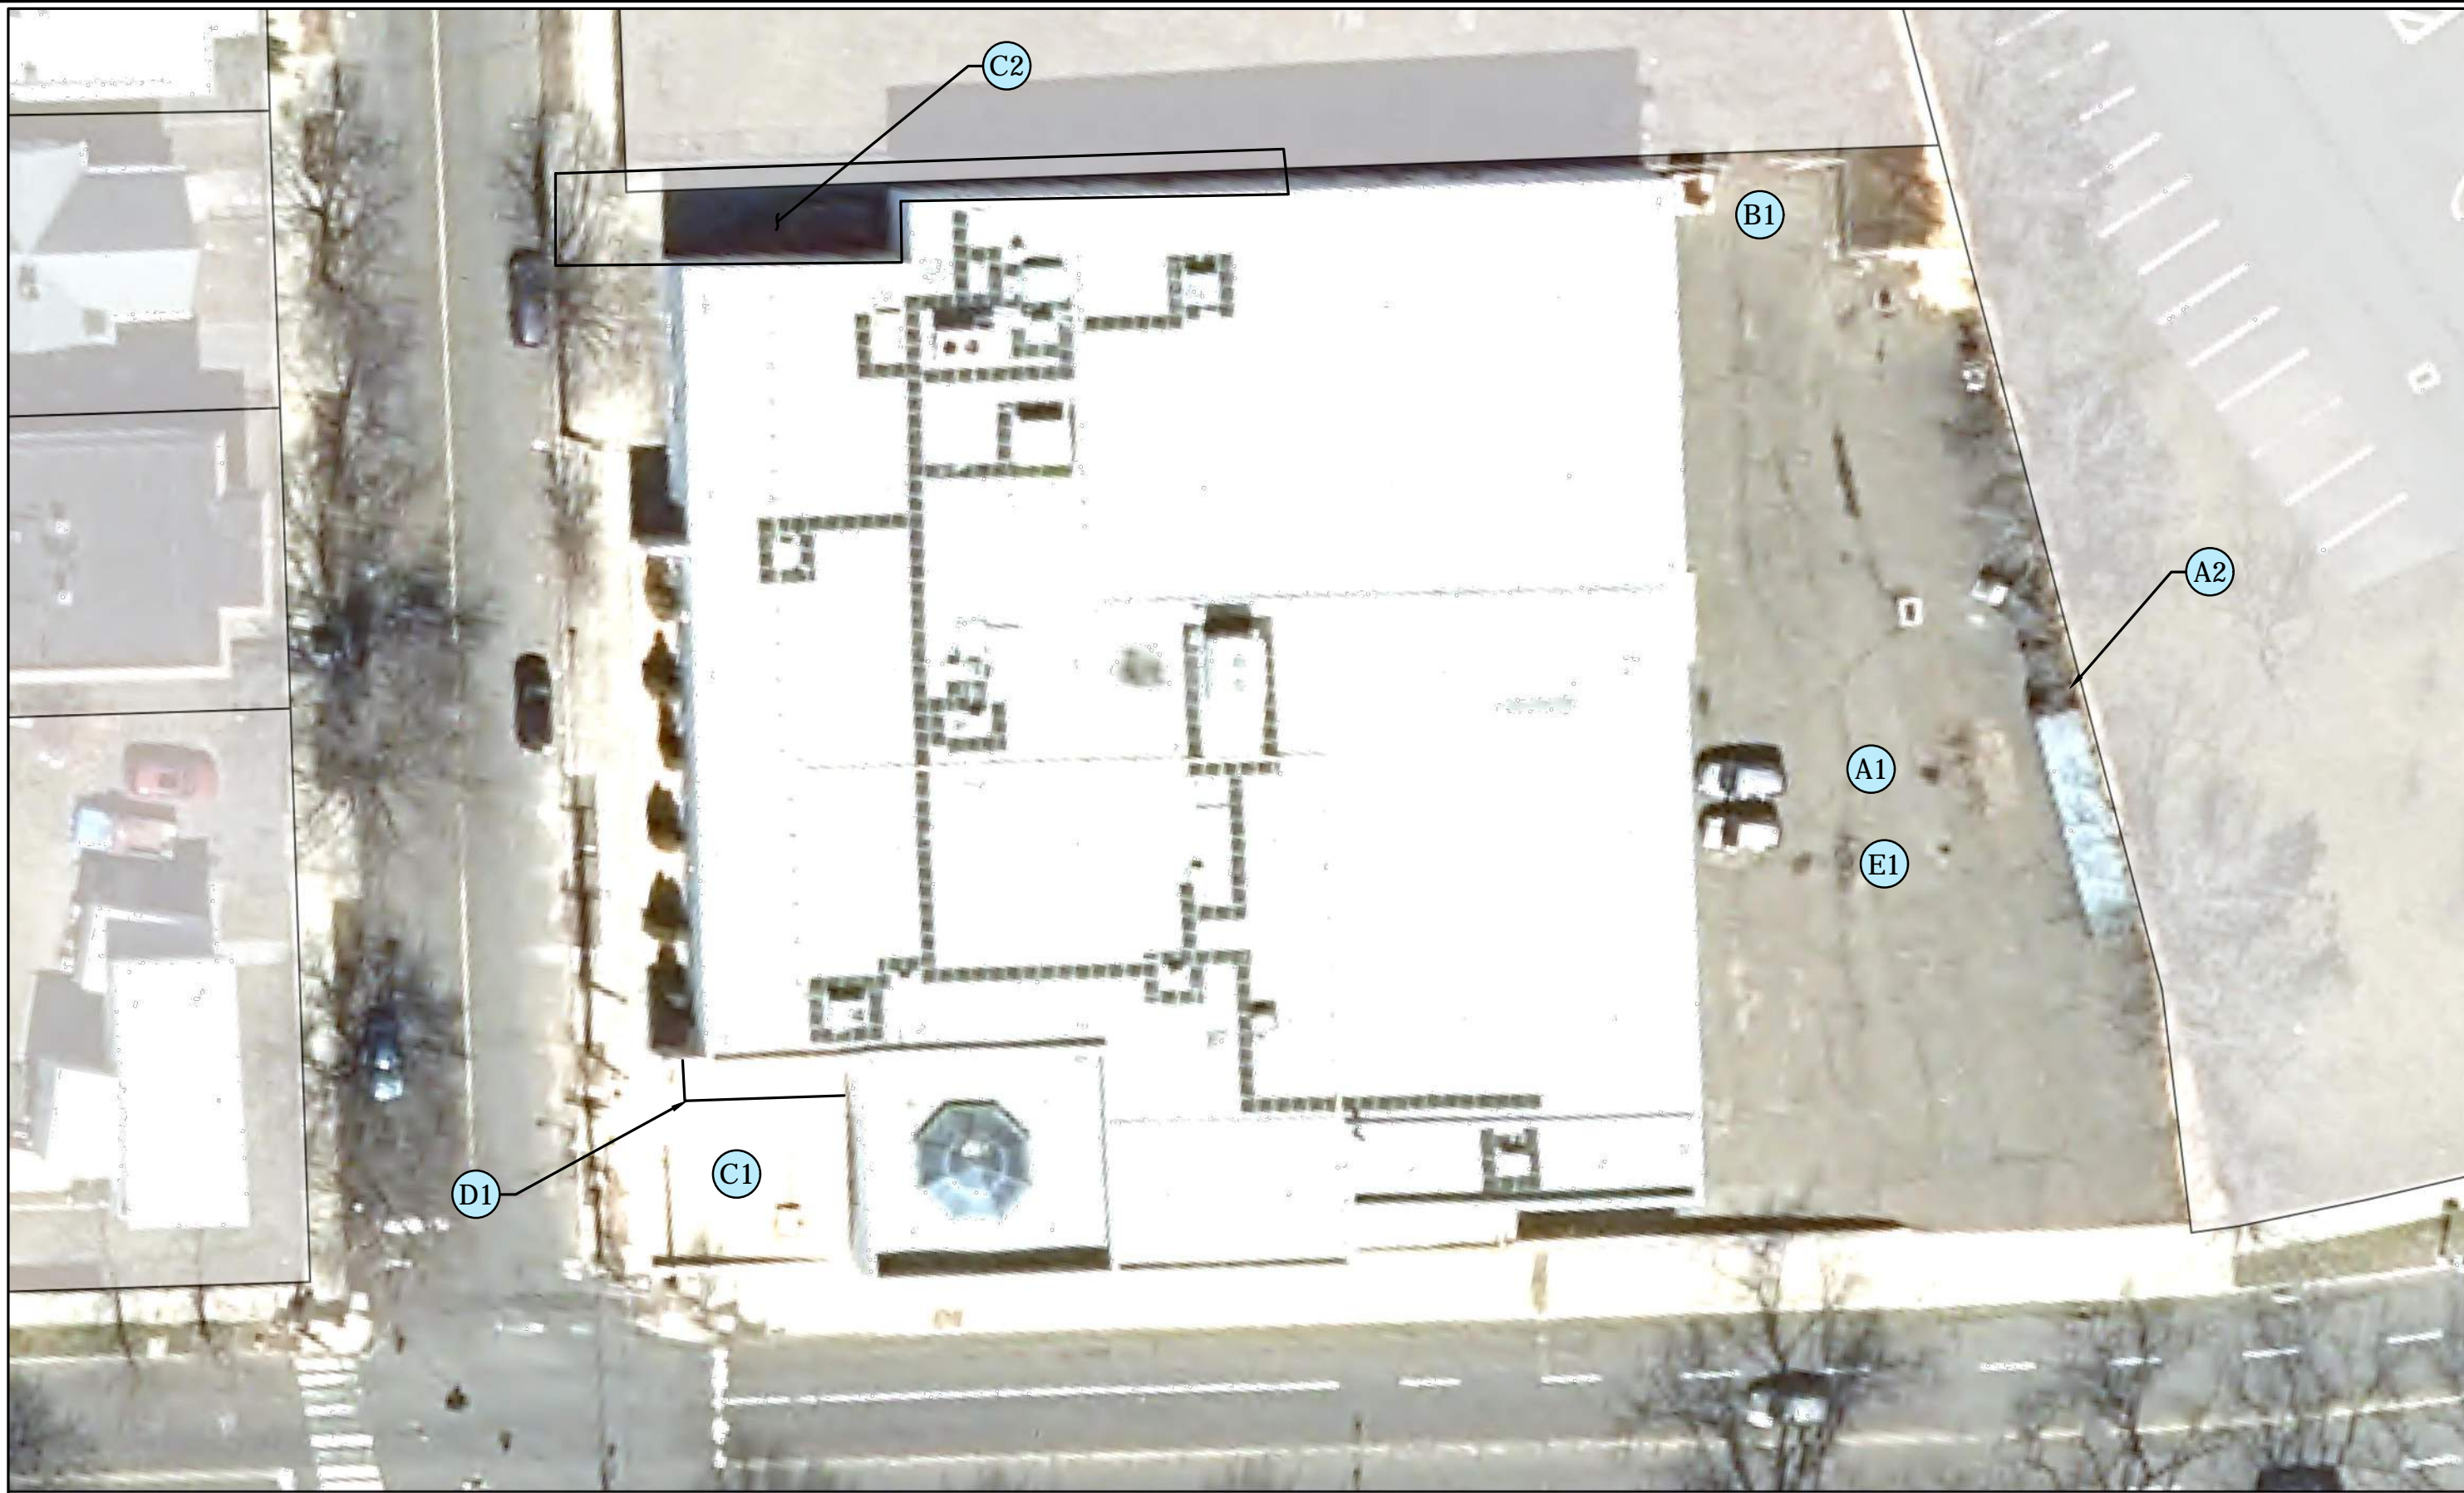
Riverside Academy

There is no parking on site, there is a small driveway. The paved area is in poor condition with evidence of heavy cracking and pavement section deterioration. A sidewalk surface needs to be installed to the stairs on the east side of the building. Site lighting seems to be adequate, but a photometric plan should be done to see where deficiencies exist. Storm water from the roofs, landscaped areas, and paved areas flows into on site inlets and catch basins with underground piping connected to the municipal storm water management system.

ITEM	CORRECTION	PRIORITY	REASON	LOCATION	NOTES
A. G2020- Parking Lots					
1	Correct Bituminous Driveway Deterioration by Demolition and Replacement	2	Damage/Wear	West Corner of Site	
B. G2030.10- Pedestrian Pavement					
1	Correct Concrete Sidewalk Deterioration by Install New	2	Damage/Wear	North Corner of School	Add Walk to Stairs

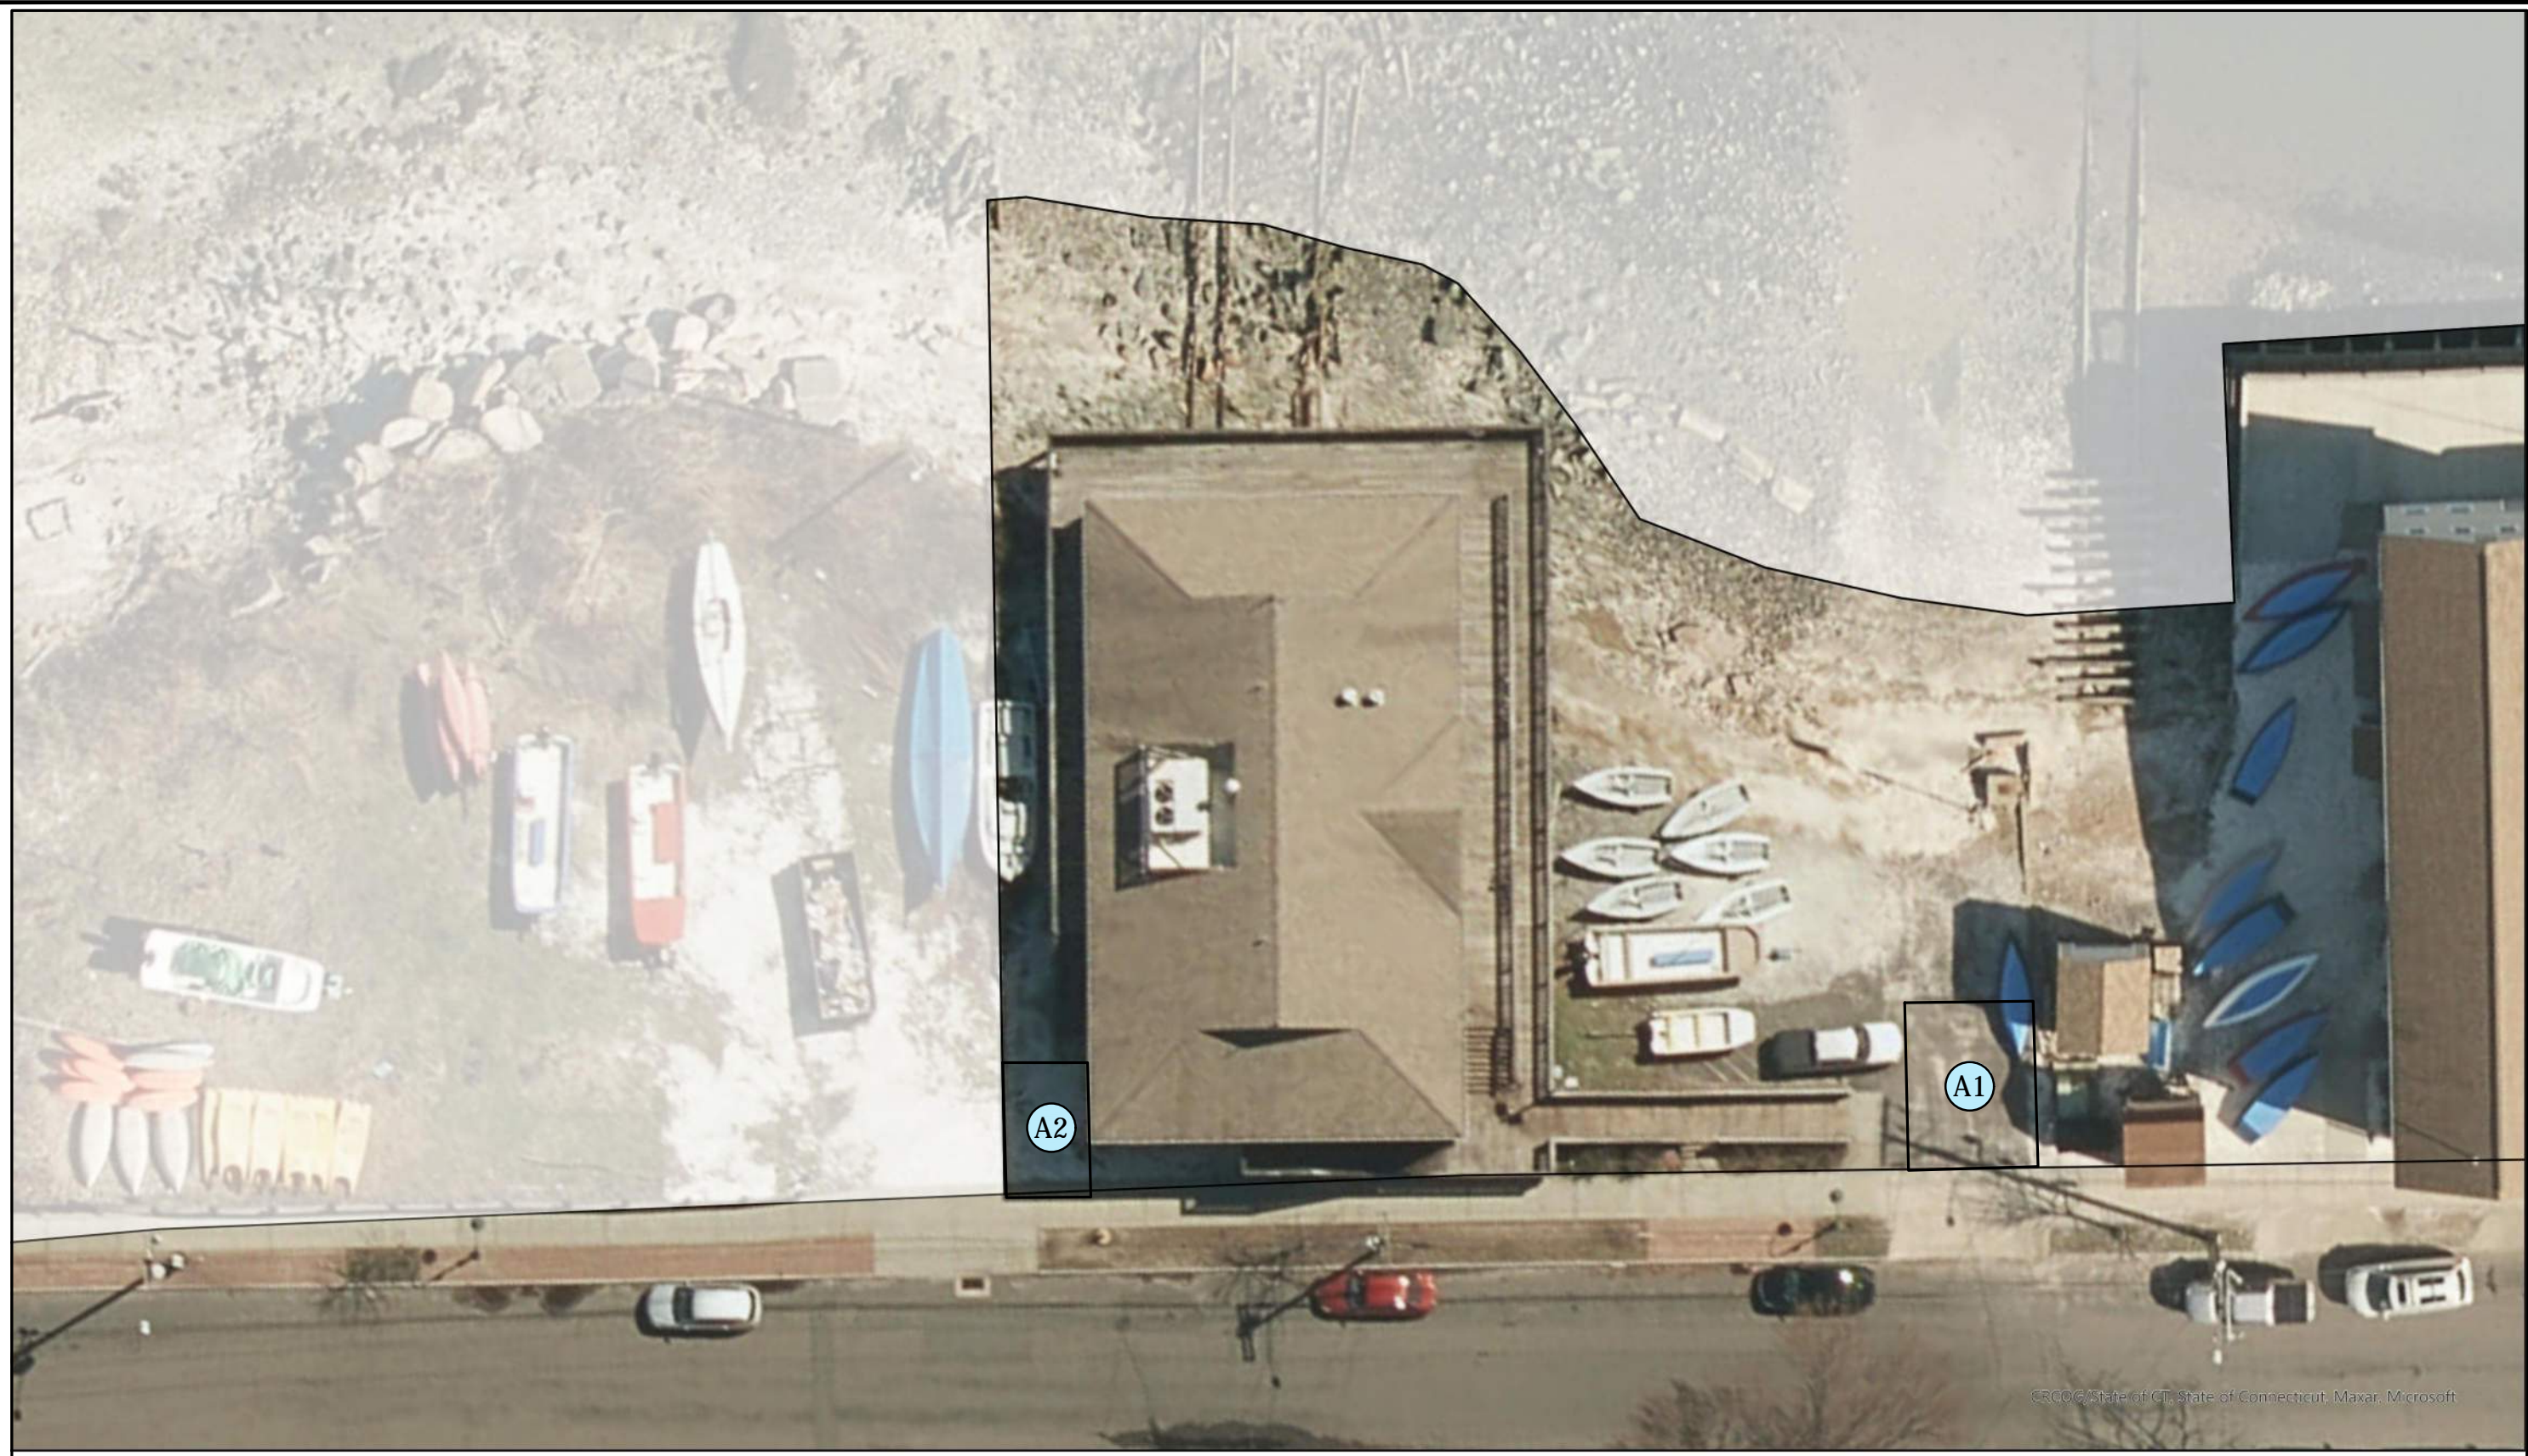
Sound School - ANDERSON BUILDING

There is one parking lot to the west of the school and a drop off circle also to the west side of the school. The paved areas are in poor condition with evidence of cracking and pavement section deterioration. The paved drive isle is in fair condition. Sidewalk surfaces are in fair to good condition. The concrete pavers to the south of the school have significant color wear. Site lighting seems to be adequate, but a photometric plan should be done to see where deficiencies exist. Also, there are two damaged poles that need to be replaced. Storm water from the roofs, landscaped areas, and paved areas flows into on site inlets and catch basins with underground piping connected to the municipal storm water management system.

ITEM	CORRECTION	PRIORITY	REASON	LOCATION	NOTES
A. G2010- Roadways					
1	Correct Bituminous Roadway Surface Deterioration by Overlay	3	Damage/Wear	Southwest Corner of Site	Drive Circle

B. G2020- Parking Lots					
1	Correct Bituminous Parking Lot Deterioration by Demolition & Full Depth Replacement	2	Damage/Wear	West Side of School	
C. Pavement					
1	Correct Concrete Pavement Deterioration by Demo & Replacement	3	Damage/Wear	North Side of School	Dumpster Pad

D. G2030.10- Pedestrian Pavement					
1	Correct Concrete Unit Paver Deterioration by Demo & Replacement	3	Damage/Wear	South Side of School	Color Worn Off on Pavers

E. G2060.85- Site Specialties					
1	Correct Steel Protection Bollard Deterioration by Demolition & Replacement	2	Damage/Wear	North Side of School	(3) Bollards

F. G4050- Site Lighting					
1	Correct Pole Mounted Site Lighting Deterioration by Demolition and Replacement	2	Damage/Wear	Southwest Corner of School	
2	Correct Pole Mounted Site Lighting by Install New	2	Damage/Wear	West Side of School	Only (2) Pole Lights in Parking Lot
