**NEW HAVEN
PUBLIC SCHOOLS
LONG-RANGE
FACILITIES
PLANNING STUDY**

Final 12-04-23

SECTION 1: DISTRICT VISION & STUDY PURPOSE

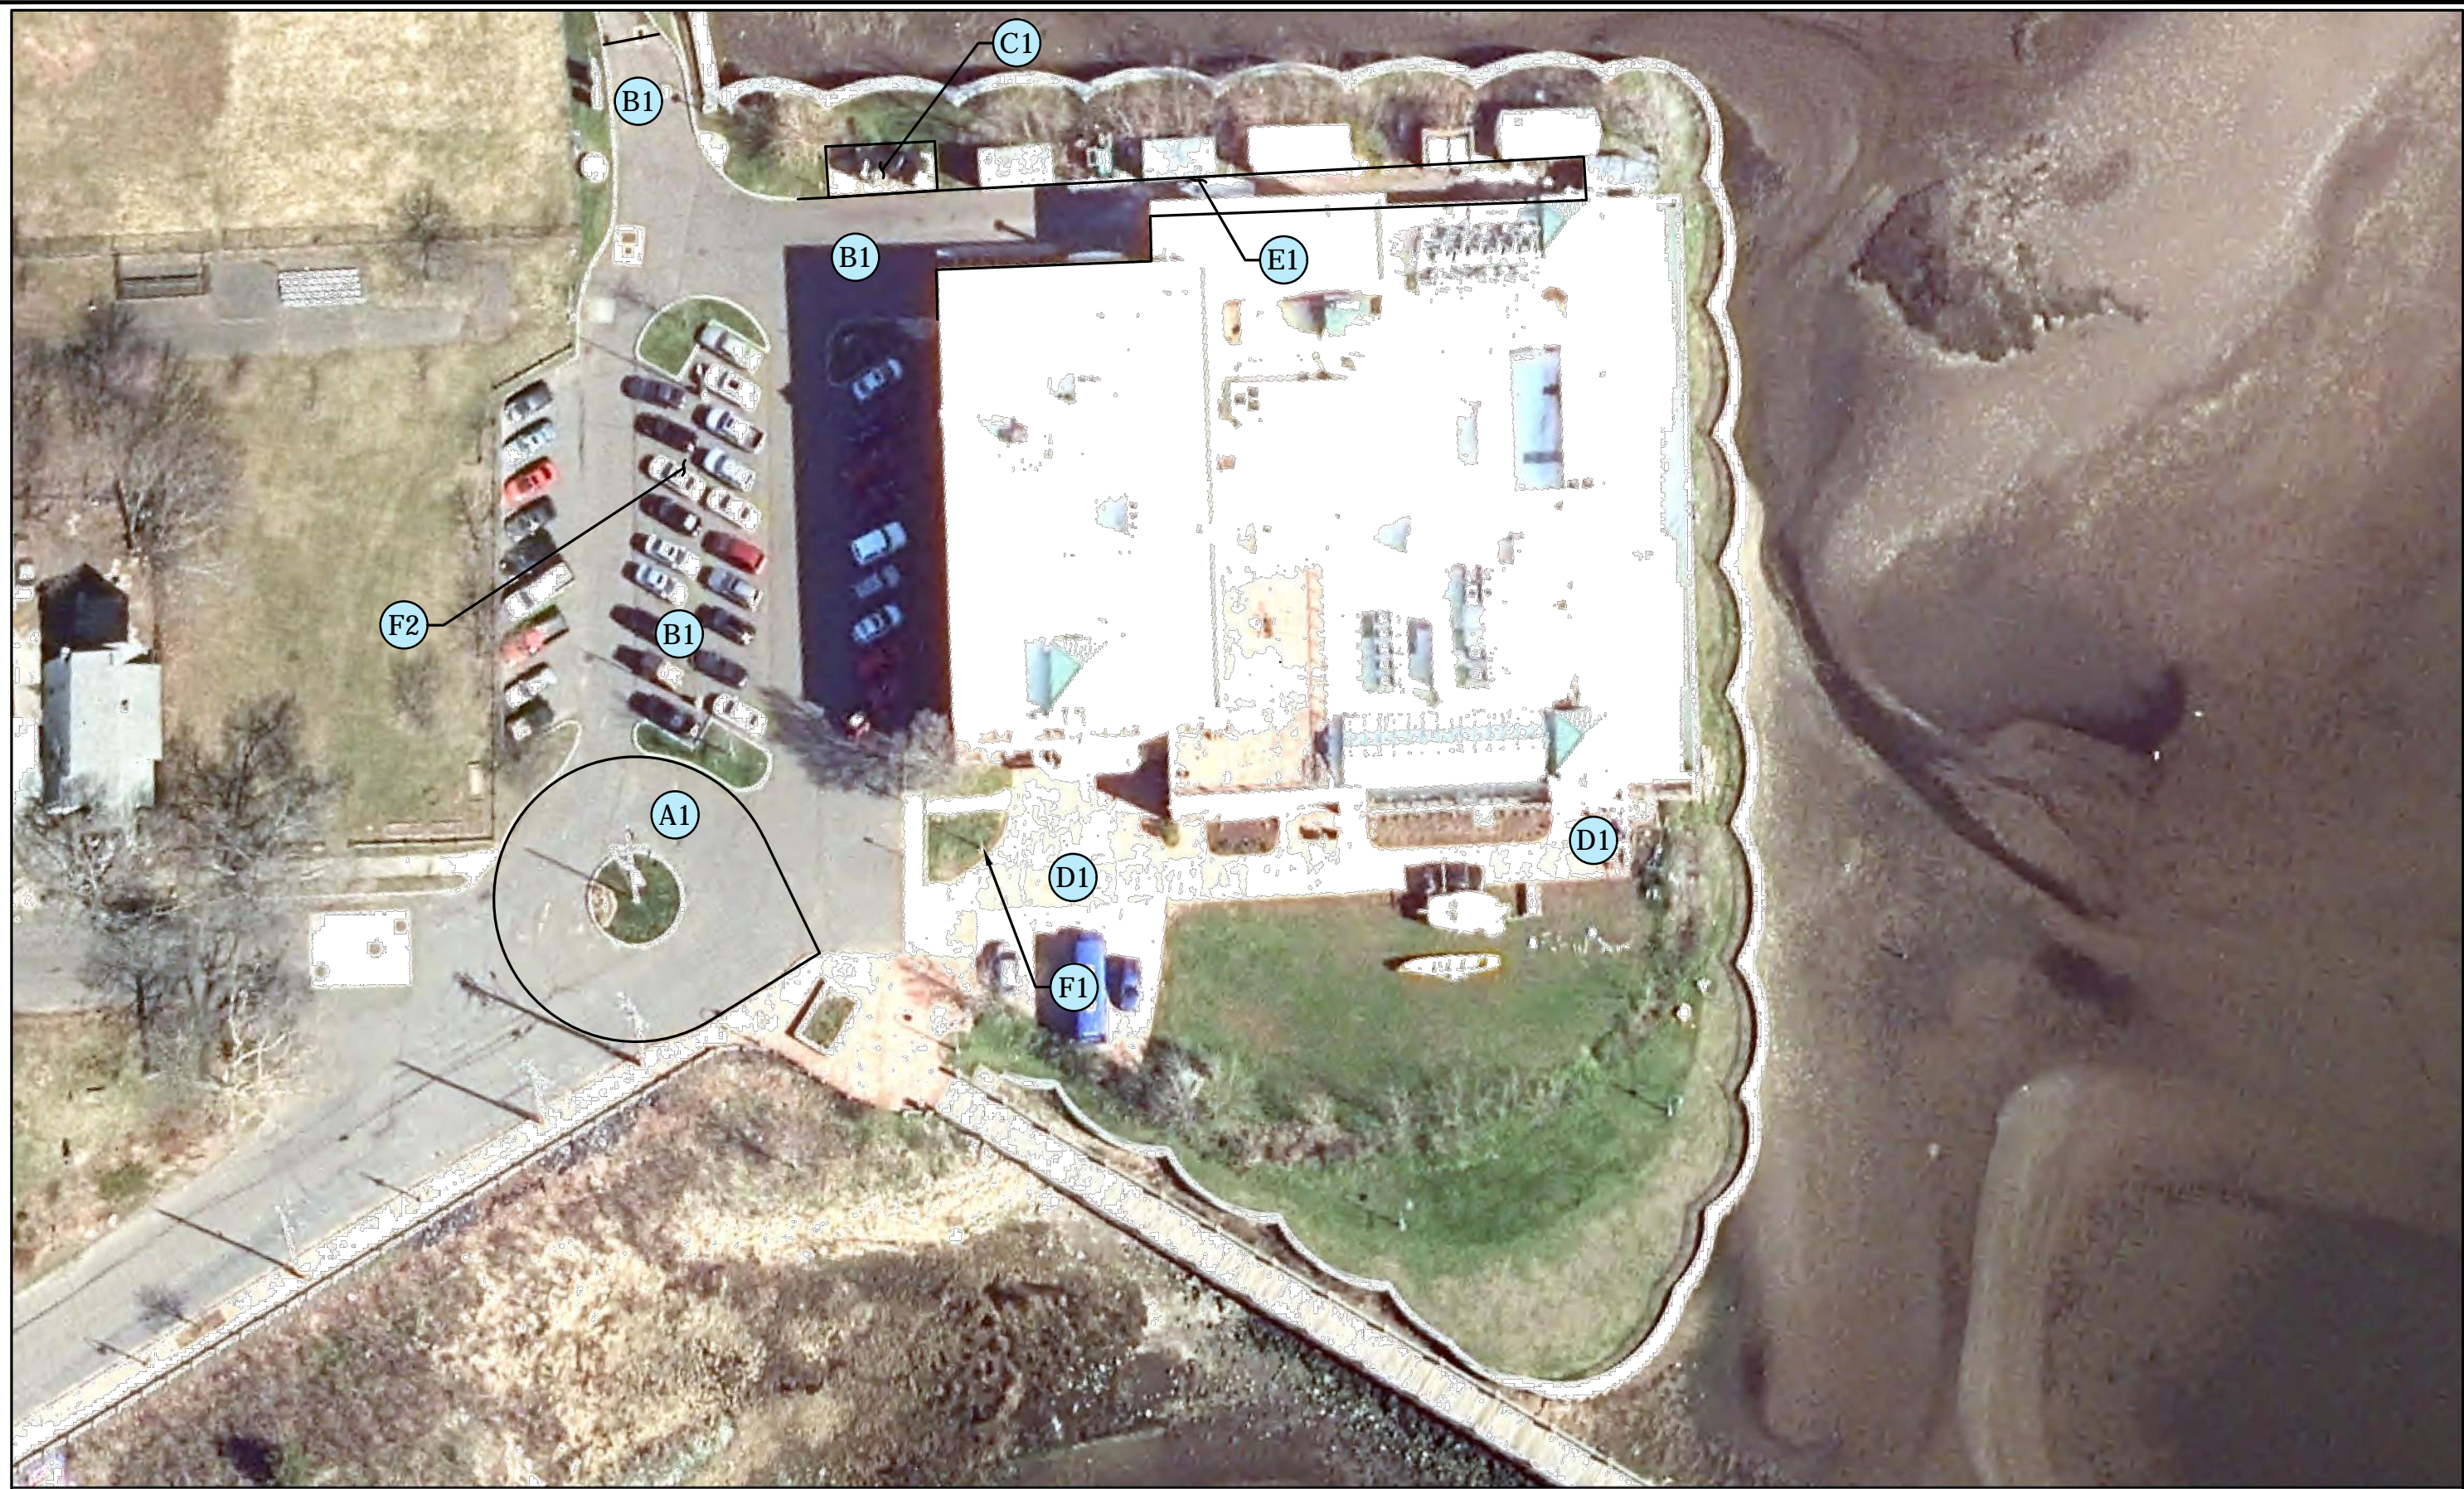
Sound School Aquaculture

There is one parking lot to the west of the building. The paved areas are in poor condition with evidence of cracking and pavement section deterioration. Sidewalk surfaces are in poor to good condition with varying levels of damage. Site lighting seems to be adequate, but a photometric plan should be done to see where deficiencies exist. Storm water from the roofs, landscaped areas, and paved areas flows into on site inlets and catch basins with underground piping connected to the municipal storm water management system.

ITEM	CORRECTION	PRIORITY	REASON	LOCATION	NOTES
A. G2020- Parking Lots					
1	Correct Gravel Parking Lot Deterioration by Demolition & Replacement with Alternate Material (Bituminous)	2	Damage/ Wear	Southwest Side of School	
2	Correct Concrete Parking Lot Deterioration by Demolition & Replacement with Alternate Material (Bituminous)	2	Damage/ Wear	Southwest Side of School	Accessible Spaces are Concrete Currently
3	Correct Parking Lot Curb Deterioration by Install New (Concrete)	2	Damage/ Wear	Southwest Side of School	No Curbs Currently
B. G2030.10- Pedestrian Pavement					
1	Correct Concrete Sidewalk Deterioration by Demo & Replacement	2	Damage/ Wear	West Side of School	
C. G4050- Site Lighting					
1	Correct Pole Mounted Site Lighting Deterioration by Demolition and Replacement	1	Damage/ Wear	Southwest Side of School	(1) Broken Pole Light

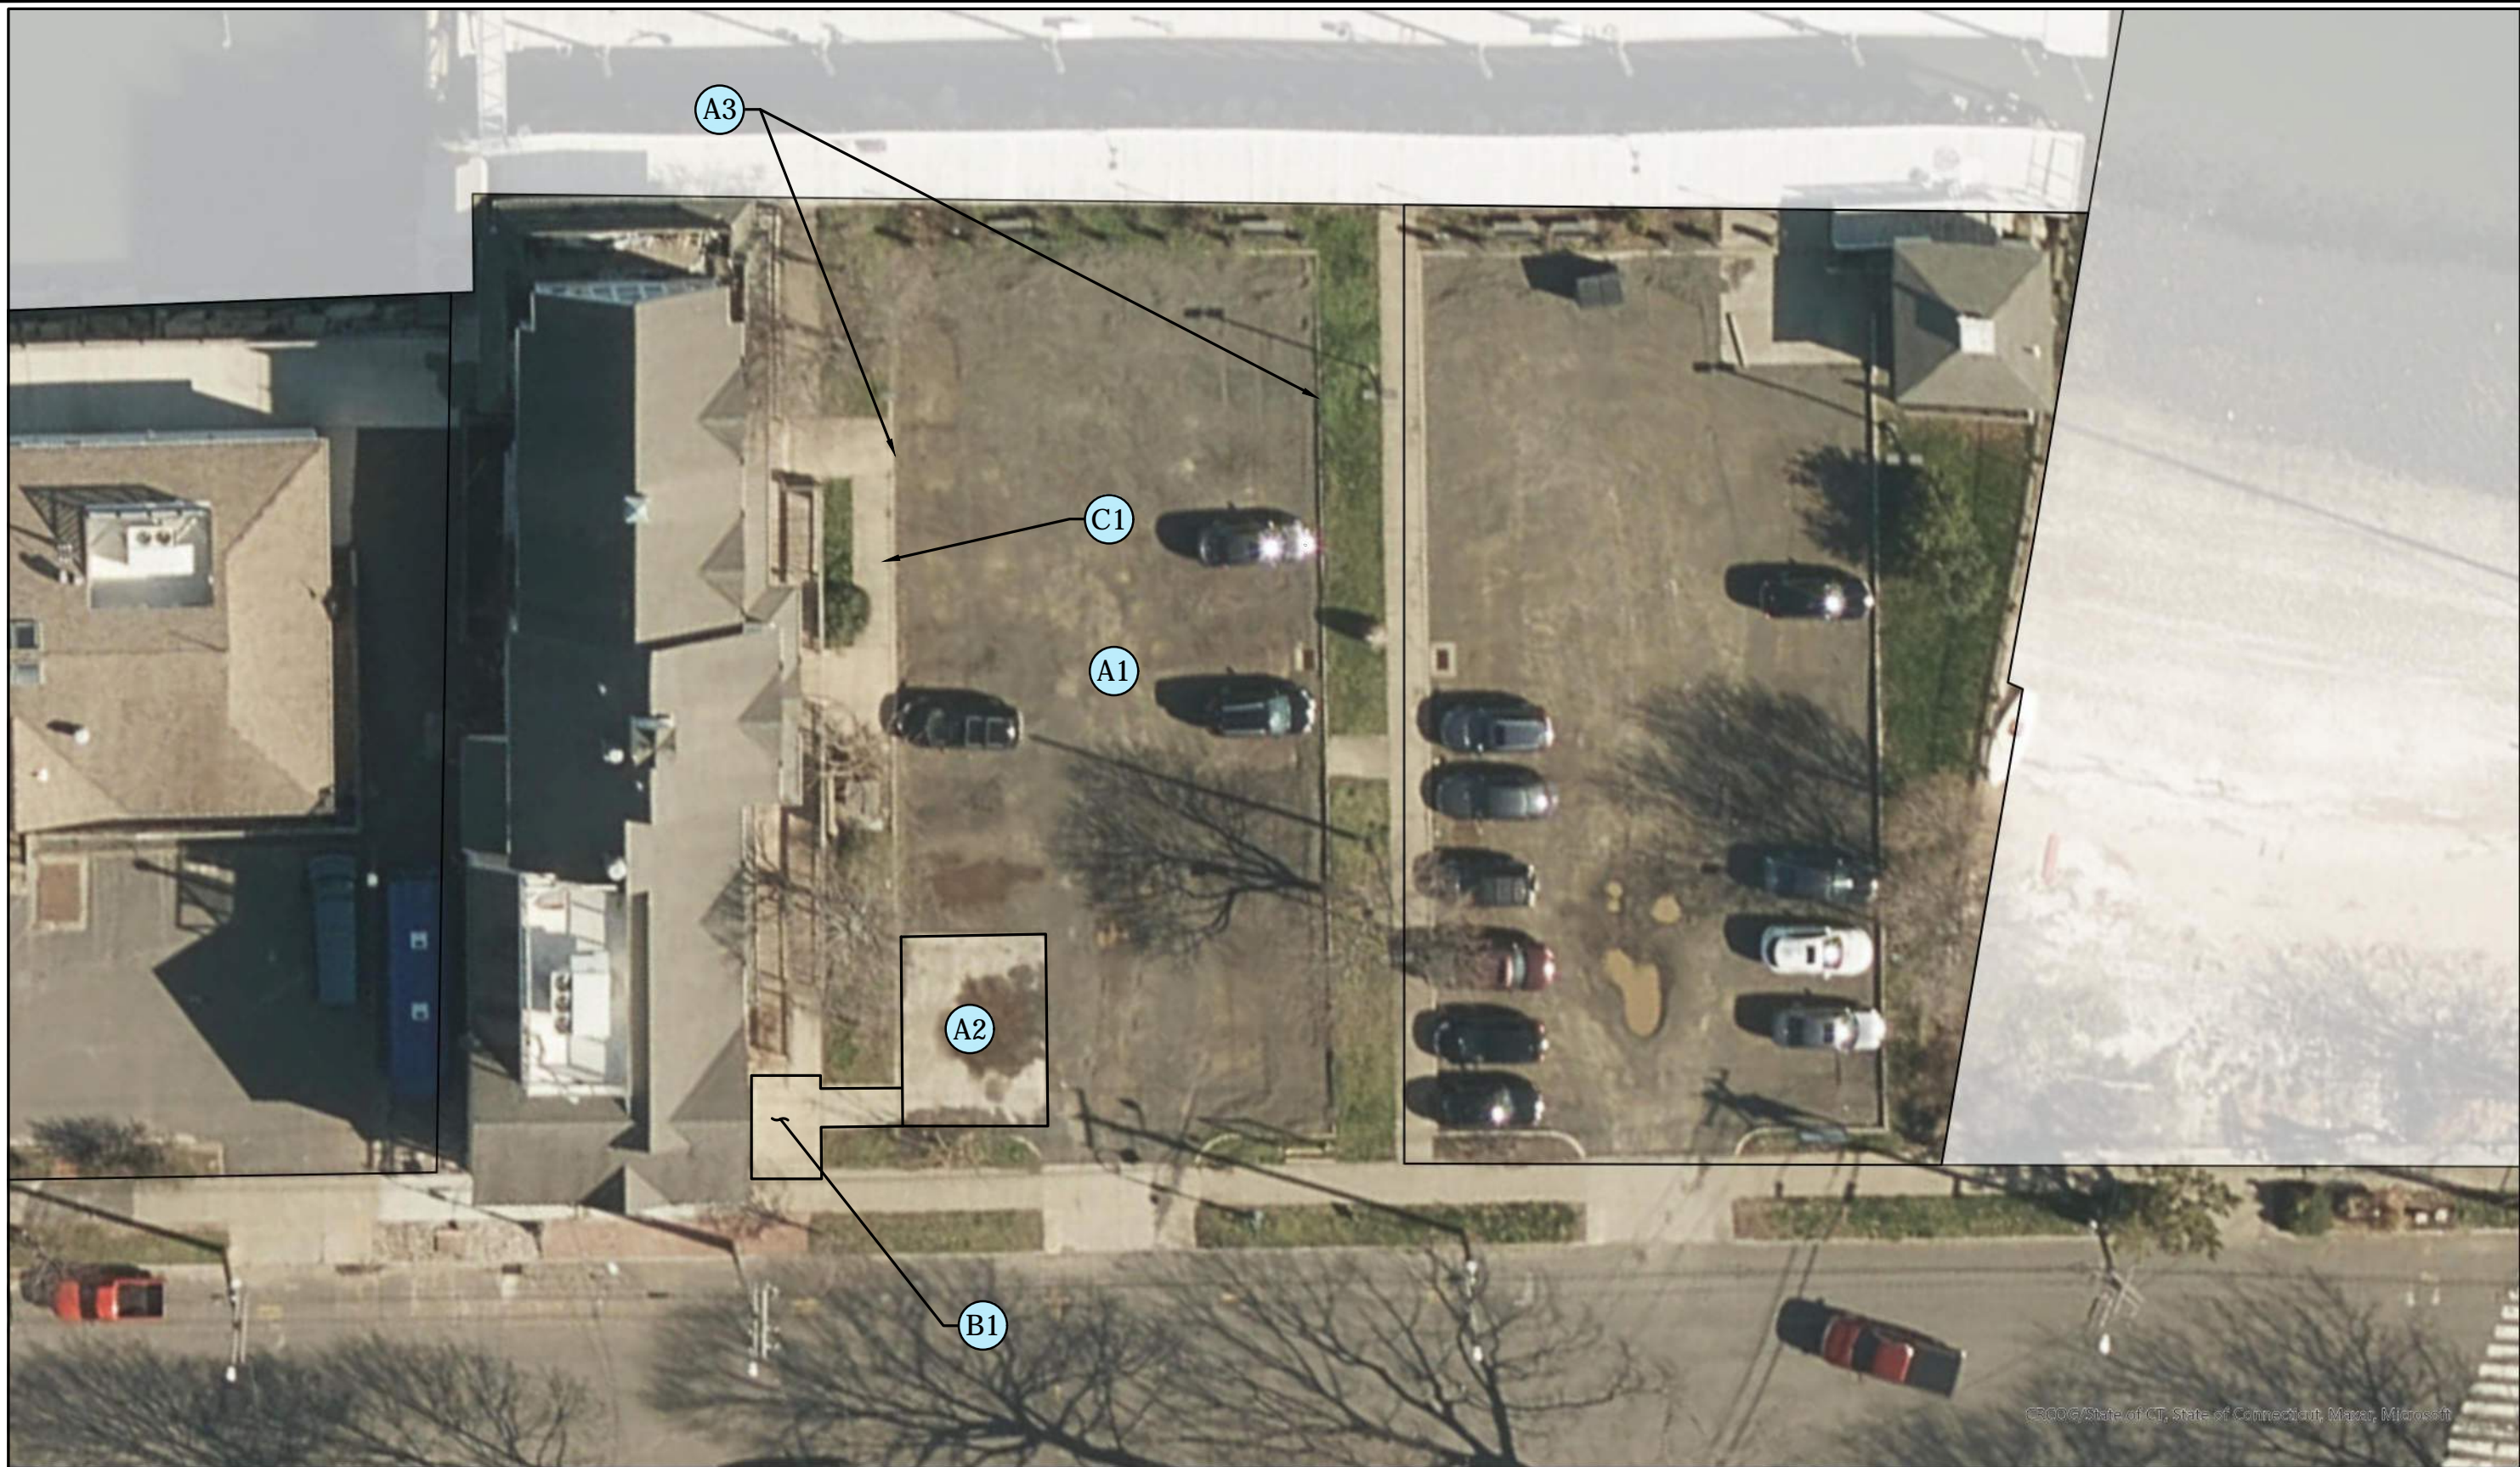
Sound School - Emmerson Building

There is one parking lot to the north of the building. The paved area is in fair condition with evidence of cracking and pavement section deterioration. Sidewalk surfaces are in poor to good condition with varying levels of damage. Site lighting seems to be adequate, but a photometric plan should be done to see where deficiencies exist. Storm water from the roofs, landscaped areas, and paved areas flows into on site inlets and catch basins with underground piping connected to the municipal storm water management system.

ITEM	CORRECTION	PRIORITY	REASON	LOCATION	NOTES
A.	G2020- Parking Lots				
1	Correct Bituminous Parking Lot Deterioration by Demolition & Replacement	3	Damage/Wear	Northwest Side of School	
B.	G2030.10- Pedestrian Pavement				
1	Correct Concrete Sidewalk Deterioration by Demo & Replacement	2	Damage/Wear	Northwest Side of School	Bottom of Front Stairs
2	Correct Concrete Sidewalk Deterioration by Demo & Replacement	2	Damage/Wear	North Corner of School	
2	Correct Bituminous Concrete Sidewalk Deterioration by Demo & Replacement	2	Damage/Wear	North Corner of School
